Access Compliance Report

Public Rights-of-Way

(Curb Ramps)

Intersection ID: 11828	Main Street: GREENLEAF_AV	Cross Street: MCNINCH_ST	Location: E
ADA ID: 4F2304052193	Ramp Type: PerpDiag	Initial Pass/Fail: Fail	Overall Compliance: No
			Severity Score: 13.75

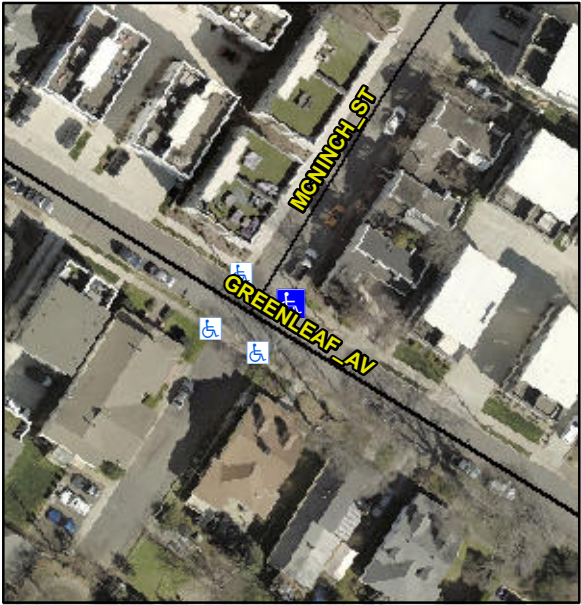
N/A	X Walk 2 Width (in)	N/A
			0.4	X Walk 2 Slope (%)	9.6
			1.8	X Walk 2 X Slope (%)	2.6
			N/A	Ramp inside XWalk2?	N/A
			2.3	Clear Space?	N/A
			1.6	Clear Space to XWalk (in)	N/A
			N/A	Storm Grate/Utility Hazard?	N/A
			N/A	Storm Grate/Utility Type	N/A
<p>Obstruction Type</p> <p>N/A</p>			N/A	Surface Condition? (G/P)	Good

Possible Solutions:		Compliance	Description	Data
	Remove & Replace Curb Ramp With Two New Directional Ramps or Equivalent.		No	Ramp Length (in)	60.0
			Yes	Ramp Width (in)	48.0
			N/A	Flare Type LT	N/A
			N/A	Flare Slope LT (%)	N/A
			N/A	Flare Traversable LT?	N/A
			N/A	Landing Length (in)	N/A
			N/A	Landing Width (in)	N/A
			N/A	Landing Slope (%)	N/A
			N/A	Landing X Slope (%)	N/A
<p>Surveyor Notes:</p> <p>N/A</p> <p>PROW/ADA:</p> <p>Not Found, R304.2.2, R304.5.3</p>			N/A	Flare Type RT	N/A
			N/A	Flare Slope RT (%)	N/A
			N/A	Flare Traversable RT?	N/A
			N/A	DWS Provided?	N/A
			N/A	DWS Contrast?	N/A
			N/A	DWS Length (in)	N/A
			N/A	DWS Full Width?	N/A
			N/A	DWS Offset (in)	N/A
			N/A	Gutter Ponding?	N/A
			N/A	Gutter Lip Ht (in)	N/A
<p>Total Cost:</p> <p>\$ 3200.00</p>			No	Painted X Walk2?	No
			To NW	X Walk 2 Direction	To SW
