Access Compliance Report Public Rights-of-Way (Curb Ramps)

Intersection ID: 17531 Main Street: HILLSIDE AV **Cross Street: WESTFIELD RD** Location: SE ADA ID: 4F256BB78F73 Ramp Type: PerpDiag Initial Pass/Fail: Fail **Overall Compliance: No Severity Score:** 35

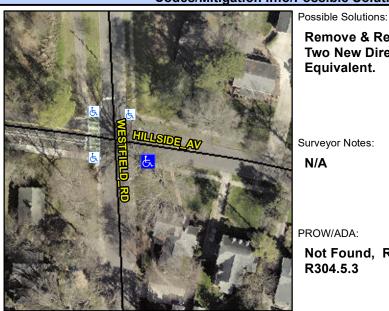
Not Found, R304.5.1, R304.2.2, R304.5.3

Compl	iance Description	Data	Compli	iance	Description	Data
N/A	Ramp Length (in)	56.0	No	Ramp	Slope (%)	12.0
No	Ramp Width (in)	47.0	No	Ramp	XSlope (%)	4.6
N/A	Flare Type LT	N/A	N/A	Flare	Type RT	N/A
N/A	Flare Slope LT (%)	N/A	N/A	Flare	Slope RT (%)	N/A
N/A	Flare Traversable LT?	N/A	N/A	Flare	Traversable RT?	N/A
N/A	Landing Length (in)	N/A	N/A	DWS	Provided?	N/A
N/A	Landing Width (in)	N/A	N/A	DWS	Contrast?	N/A
N/A	Landing Slope (%)	N/A	N/A	DWS	Length (in)	N/A
N/A	Landing X Slope (%)	N/A	N/A	DWS	Full Width?	N/A
N/A	Landing Curb? (Y/N)	N/A	N/A	DWS	Offset (in)	N/A
N/A	Shared Landing?	N/A				
N/A	Gutter Ponding?	N/A	N/A	Gutte	r Slope (%)	N/A
N/A	Gutter Lip Ht (in)	N/A	N/A	Gutte	r X Slope (%)	N/A
N/A	Painted X Walk1?	No	N/A	Paint	ed X Walk2?	No
	X Walk 1 Direction	To N		X Wa	lk 2 Direction	To NW
N/A	X Walk 1 Width (in)	N/A	N/A	X Wa	lk 2 Width (in)	N/A
	X Walk 1 Slope (%)	6.0		X Wa	lk 2 Slope (%)	2.7
	X Walk 1 X Slope (%)	4.4		X Wa	lk 2 X Slope (%)	3.1

N/A	Ramp inside XWalk1?	N/A	N/A	Ramp	inside XWalk2?	N/A
	Road Slope (%)	5.4	N/A	Clear	Space?	N/A
	Road X Slope (%)	3.8	N/A	Clear	Space to XWalk (in)	N/A
N/A	Any Obstructions?	N/A	N/A	Storn	n Grate/Utility Hazard?	N/A
	Obstruction Type			Storn	n Grate/Utility Type	
		N/A	l			N/A

Street 1 Name Stop Condition-Street 2 Street 2 Name Stop Condition-Street 1 Two New Directional Ramps or Equivalent.

Remove & Replace Curb Ramp With
