Access Compliance Report

Public Rights-of-Way

(Curb Ramps)

Intersection ID: 16765	Main Street: CHURCHILL_RD	Cross Street: N_WENDOVER_RD	Location: NE
ADA ID: 4F29A7680C3A	Ramp Type: BlendTrans1	Initial Pass/Fail: Fail	Overall Compliance: No
		Severity Score: 10

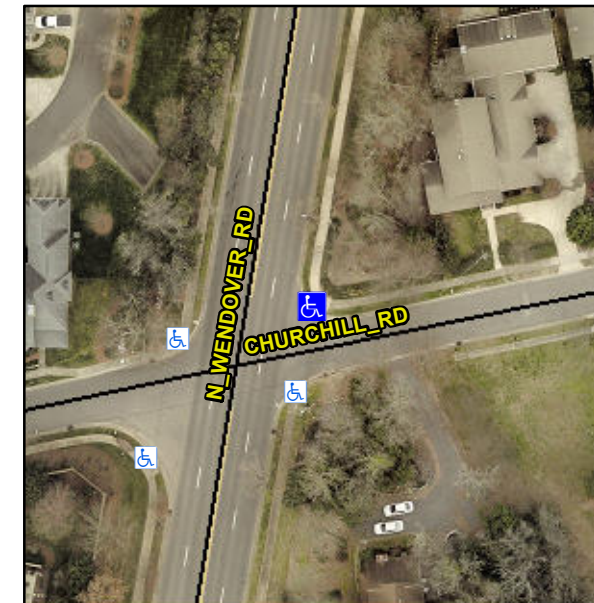
Not Found, R304.5.1, R304.5.3

Compliance	Description	Data	Compliance	Description	Data
N/A	Ramp Length (in)	50.0	Yes	BlendTrans Slope (%)	3.7
No	Ramp Width (in)	47.0	No	BlendTrans XSlope (%)	4.2
N/A	Flare Type LT	N/A	N/A	Flare Type RT	N/A
N/A	Flare Slope LT (%)	N/A	N/A	Flare Slope RT (%)	N/A
N/A	Flare Traversable LT?	N/A	N/A	Flare Traversable RT?	N/A
N/A	Landing Length (in)	N/A	N/A	DWS Provided?	N/A
N/A	Landing Width (in)	N/A	N/A	DWS Contrast?	N/A
N/A	Landing Slope (%)	N/A	N/A	DWS Length (in)	N/A
N/A	Landing X Slope (%)	N/A	N/A	DWS Full Width?	N/A
N/A	Landing Curb? (Y/N)	N/A	N/A	DWS Offset (in)	N/A
N/A	Shared Landing?	N/A			
N/A	Gutter Ponding?	N/A	N/A	Gutter Slope (%)	N/A
N/A	Gutter Lip Ht (in)	N/A	N/A	Gutter X Slope (%)	N/A
N/A	Painted X Walk1?	No	N/A	Painted X Walk2?	No
	X Walk 1 Direction	To SW		X Walk 2 Direction	To S
	X Walk 1 Width (in)	N/A		X Walk 2 Width (in)	N/A
	X Walk 1 Slope (%)	0.9		X Walk 2 Slope (%)	6.6
	X Walk 1 X Slope (%)	4.1		X Walk 2 X Slope (%)	0.5

N/A	Ramp inside XWalk1?	N/A	N/A	Ramp inside XWalk2?	N/A
	Road Slope (%)	4.9		Clear Space?	N/A
	Road X Slope (%)	3.0	N/A	Clear Space to XWalk (in)	N/A
N/A	Any Obstructions?	N/A	N/A	Storm Grate/Utility Hazard?	N/A
	Obstruction Type			Storm Grate/Utility Type	
		N/A			N/A
			Yes	Surface Condition? (G/P)	Good
			No	Curb Slope (%)	25.4

Remove & Replace Curb Ramp With Two New Directional Ramps or Equivalent.
