# Access Compliance Report

## Public Rights-of-Way

### (Curb Ramps)

Intersection ID: 30290	Main Street: BLACK_KETTLE_DR	Cross Street: EUROSTAR_DR	Location: W
ADA ID: 4F312CE4F04A	Ramp Type: PerpDiag	Initial Pass/Fail: Fail	Overall Compliance: No
Codes/Mitigation Info/Possible Solution		Field Measurements/Component Compliance

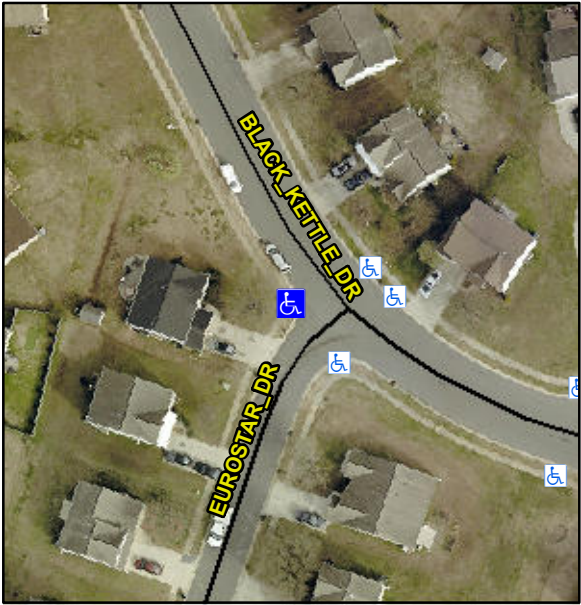
Possible Solutions:						
	Remove & Replace Curb Ramp With Two New Directional Ramps or Equivalent.	N/A	Ramp Length (in)	49.0	Yes	Ramp Slope (%)	7.7
		No	Ramp Width (in)	46.0	No	Ramp XSlope (%)	6.2
		N/A	Flare Type LT	N/A	N/A	Flare Type RT	N/A
		N/A	Flare Slope LT (%)	N/A	N/A	Flare Slope RT (%)	N/A
		N/A	Flare Traversable LT?	N/A	N/A	Flare Traversable RT?	N/A
		N/A	Landing Length (in)	N/A	N/A	DWS Provided?	N/A
		N/A	Landing Width (in)	N/A	N/A	DWS Contrast?	N/A
		N/A	Landing Slope (%)	N/A	N/A	DWS Length (in)	N/A
		N/A	Landing X Slope (%)	N/A	N/A	DWS Full Width?	N/A
		N/A	Landing Curb? (Y/N)	N/A	N/A	DWS Offset (in)	N/A
		N/A	Shared Landing?	N/A			
		N/A	Gutter Ponding?	N/A	N/A	Gutter Slope (%)	N/A
		N/A	Gutter Lip Ht (in)	N/A	N/A	Gutter X Slope (%)	N/A
		N/A	Painted X Walk1?	No	N/A	Painted X Walk2?	No
			X Walk 1 Direction	To NE		X Walk 2 Direction	To SE
		N/A	X Walk 1 Width (in)	N/A	N/A	X Walk 2 Width (in)	N/A

X Walk 1 Slope (%)	7.0		X Walk 2 Slope (%)	5.5
			X Walk 1 X Slope (%)	0.6		X Walk 2 X Slope (%)	7.4
		N/A	Ramp inside XWalk1?	N/A	N/A	Ramp inside XWalk2?	N/A
<p>Surveyor Notes:</p> <p>N/A</p> <p>PROW/ADA:</p> <p>Not Found, R304.5.1, R304.5.3</p>			Road Slope (%)	7.0	N/A	Clear Space?	N/A
			Road X Slope (%)	5.0	N/A	Clear Space to XWalk (in)	N/A
		N/A	Any Obstructions?	N/A	N/A	Storm Grate/Utility Hazard?	N/A
			Obstruction Type			Storm Grate/Utility Type	
					N/A		N/A
					Yes	Surface Condition? (G/P)	Good
