# Access Compliance Report

## Public Rights-of-Way

### (Curb Ramps)

| Intersection ID: 10768 | Main Street: BERRYHILL_RD | Cross Street: STATE_ST | Location: W |

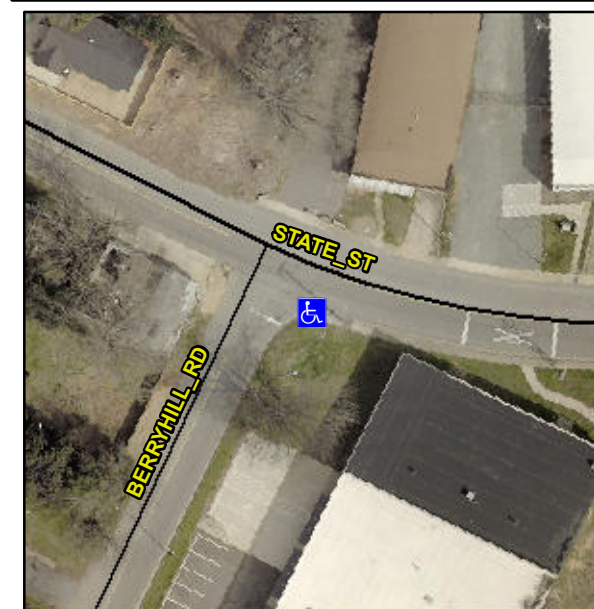
| ADA ID: 4F3DEE54362F | Ramp Type: Perp | Initial Pass/Fail: Fail | Overall Compliance: No |

**Not Found, R304.5.3**

| Compliance | Description | Data | Compliance | Description | Data |
|---|---|---|---|---|---|
| N/A | Ramp Length (in) | 54.0 | Yes | Ramp Slope (%) | 7.2 |
| Yes | Ramp Width (in) | 48.0 | No | Ramp XSlope (%) | 10.3 |

**Remove & Replace Entire Ramp.**
