Access Compliance Report

Public Rights-of-Way

(Curb Ramps)

Intersection ID: 43251	Main Street: PARK_RD	Cross Street: PARK_SOUTH_DR	Location: NE
ADA ID: 4F5875CD7F2D	Ramp Type: Perp	Initial Pass/Fail: Fail	Overall Compliance: No
			Severity Score: 26.25

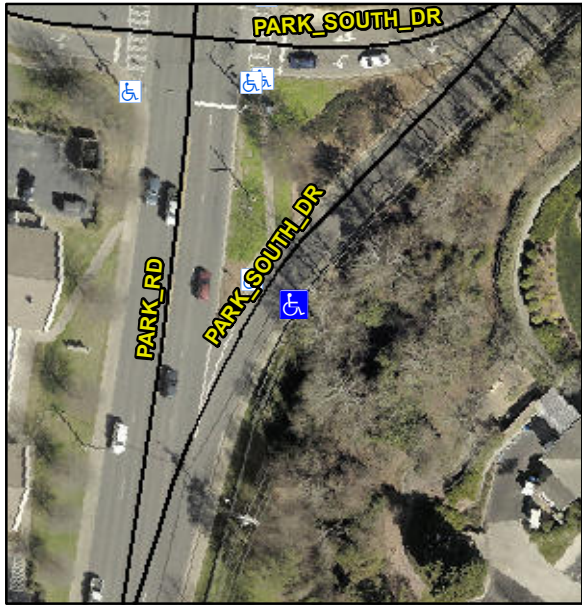
Possible Solutions:		Compliance	Description	Data	Compliance	Description	Data
	Remove & Replace Entire Ramp.		N/A	Ramp Length (in)	61.0	No	Ramp Slope (%)	14.5
			Yes	Ramp Width (in)	48.0	No	Ramp XSlope (%)	2.4
			N/A	Flare Type LT	N/A	N/A	Flare Type RT	N/A
			N/A	Flare Slope LT (%)	N/A	N/A	Flare Slope RT (%)	N/A
			N/A	Flare Traversable LT?	N/A	N/A	Flare Traversable RT?	N/A
			N/A	Landing Length (in)	N/A	N/A	DWS Provided?	N/A
			N/A	Landing Width (in)	N/A	N/A	DWS Contrast?	N/A
			N/A	Landing Slope (%)	N/A	N/A	DWS Length (in)	N/A
			N/A	Landing X Slope (%)	N/A	N/A	DWS Full Width?	N/A
Surveyor Notes:			N/A	Landing Curb? (Y/N)	N/A	N/A	DWS Offset (in)	N/A
PROW/ADA:			N/A	Shared Landing?	N/A			
Not Found, R304.2.2, R304.5.3			N/A	Gutter Ponding?	N/A	N/A	Gutter Slope (%)	N/A
			N/A	Gutter Lip Ht (in)	N/A	N/A	Gutter X Slope (%)	N/A

N/A	Painted X Walk1?	No	N/A	Painted X Walk2?	N/A
				X Walk 1 Direction	To NW		X Walk 2 Direction	N/A
			N/A	X Walk 1 Width (in)	N/A	N/A	X Walk 2 Width (in)	N/A
				X Walk 1 Slope (%)	4.1		X Walk 2 Slope (%)	N/A
				X Walk 1 X Slope (%)	0.7		X Walk 2 X Slope (%)	N/A
			N/A	Ramp inside XWalk1?	N/A	N/A	Ramp inside XWalk2?	N/A
				Road Slope (%)	N/A	N/A	Clear Space?	N/A
				Road X Slope (%)	N/A	N/A	Clear Space to XWalk (in)	N/A
			N/A	Any Obstructions?	N/A	N/A	Storm Grate/Utility Hazard?	N/A
				Obstruction Type			Storm Grate/Utility Type	
					N/A			N/A
						Yes	Surface Condition? (G/P)	Good
