Access Compliance Report

Public Rights-of-Way

(Curb Ramps)

Intersection ID: 9735	Main Street: TINNIN_AV	Cross Street: GENESIS_PARK_PL	Location: NE
ADA ID: 4F5A1E981E4A	Ramp Type: Perp	Initial Pass/Fail: Fail	Overall Compliance: No
Severity Score: 35			
Codes/Mitigation Info/Possible Solution		Field Measurements/Component Compliance

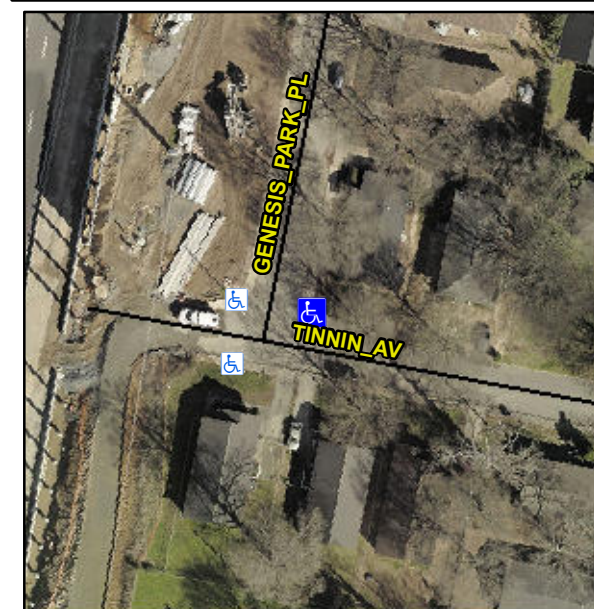
R304.5.1, R304.2.2, R304.5.3

Compliance	Description	Data	Compliance	Description	Data
N/A	Ramp Length (in)	66.0	No	Ramp Slope (%)	14.1
No	Ramp Width (in)	42.5	No	Ramp XSlope (%)	4.3
N/A	Flare Type LT	N/A	N/A	Flare Type RT	N/A
N/A	Flare Slope LT (%)	N/A	N/A	Flare Slope RT (%)	N/A
N/A	Flare Traversable LT?	N/A	N/A	Flare Traversable RT?	N/A
N/A	Landing Length (in)	N/A	N/A	DWS Provided?	N/A
N/A	Landing Width (in)	N/A	N/A	DWS Contrast?	N/A
N/A	Landing Slope (%)	N/A	N/A	DWS Length (in)	N/A
N/A	Landing X Slope (%)	N/A	N/A	DWS Full Width?	N/A
N/A	Landing Curb? (Y/N)	N/A	N/A	DWS Offset (in)	N/A
N/A	Shared Landing?	N/A			
N/A	Gutter Ponding?	N/A	N/A	Gutter Slope (%)	N/A
N/A	Gutter Lip Ht (in)	N/A	N/A	Gutter X Slope (%)	N/A
N/A	Painted X Walk1?	No	N/A	Painted X Walk2?	N/A
	X Walk 1 Direction	To NW		X Walk 2 Direction	N/A
N/A	X Walk 1 Width (in)	N/A	N/A	X Walk 2 Width (in)	N/A
	X Walk 1 Slope (%)	2.6		X Walk 2 Slope (%)	N/A
	X Walk 1 X Slope (%)	2.5		X Walk 2 X Slope (%)	N/A

Remove & Replace Entire Ramp.
