## **Access Compliance Report Public Rights-of-Way** (Curb Ramps)

Intersection ID: 7836 Main Street: SNOW WHITE LN **Cross Street: SPRING GARDEN LN** Location: NW **Overall Compliance: No Severity Score:** 42.5 ADA ID: 4F601B096DD9 Ramp Type: Combination1 Initial Pass/Fail: Fail

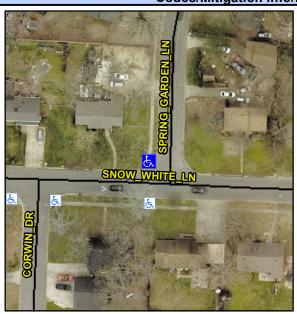
StopSign Street 1 Name **SPRING GARDEN LN** Stop Condition-Street 1 N/A Street 2 Name Stop Condition-Street 2 N/A Possible Solutions: Compliance Description N/A Remove & Replace Entire Ramp. Yes Yes Yes N/A No Surveyor Notes: N/A LT RP < 5% N/A PROW/ADA Not Found, R304.5.1, R304.2.2, R304.5.3
