## **Access Compliance Report Public Rights-of-Way** (Curb Ramps)

Intersection ID: 31758 Main Street: FIRST RUN CT Cross Street: STARNES\_RANDALL\_RD Location: NW Severity Score: 13.75 ADA ID: 4F66193F9389 Ramp Type: Perp Initial Pass/Fail: Fail **Overall Compliance: No**

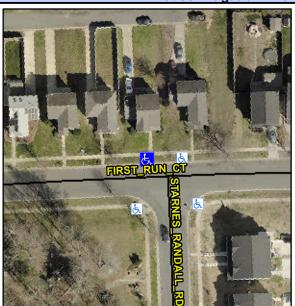
Field Measurements/Component Compliance								
Compli	iance Description	Data	Compli	iance Description	Data			
N/A	Ramp Length (in)	86.0	No	Ramp Slope (%)	10.3			
Yes	Ramp Width (in)	50.0	Yes	Ramp XSlope (%)	3.5			
N/A	Flare Type LT	N/A	N/A	Flare Type RT	N/A			
N/A	Flare Slope LT (%)	N/A	N/A	Flare Slope RT (%)	N/A			
N/A	Flare Traversable LT?	N/A	N/A	Flare Traversable RT?	N/A			
N/A	Landing Length (in)	N/A	N/A	DWS Provided?	N/A			
N/A	Landing Width (in)	N/A	N/A	DWS Contrast?	N/A			
N/A	Landing Slope (%)	N/A	N/A	DWS Length (in)	N/A			
N/A	Landing X Slope (%)	N/A	N/A	DWS Full Width?	N/A			
N/A	Landing Curb? (Y/N)	N/A	N/A	DWS Offset (in)	N/A			
N/A	Shared Landing?	N/A						
N/A	Gutter Ponding?	N/A	N/A	Gutter Slope (%)	N/A			
N/A	Gutter Lip Ht (in)	N/A	N/A	Gutter X Slope (%)	N/A			
N/A	Painted X Walk1?	No	N/A	Painted X Walk2?	N/A			
	X Walk 1 Direction	To S		X Walk 2 Direction	N/A			
N/A	X Walk 1 Width (in)	N/A	N/A	X Walk 2 Width (in)	N/A

X Walk 1 Slope (%)	5.3		X Walk 2 Slope (%)	N/A			
	X Walk 1 X Slope (%)	4.9		X Walk 2 X Slope (%)	N/A			
N/A	Ramp inside XWalk1?	N/A	N/A	Ramp inside XWalk2?	N/A			
	Road Slope (%)	N/A	N/A	Clear Space?	N/A			
	Road X Slope (%)	N/A	N/A	Clear Space to XWalk (in)	N/A			
N/A	Any Obstructions?	N/A	N/A	Storm Grate/Utility Hazard?	N/A			
	Obstruction Type			Storm Grate/Utility Type				
		N/A			N/A			
			Yes	Surface Condition? (G/P)	Good

1 COCIDIO COIGNON	
Possible Solutions:	Com
Remove & Replace Entire Ramp.	N/A
	Yes
	N/A
	N/A
	N/A
	N/A
Surveyor Notes:	N/A
N/A	N/A
	N/A
	N/A
	N/A
PROW/ADA:	N/A
Not Found, R304.2.2	N/A
	N/A
	N/A
	N/A
