Access Compliance Report

Public Rights-of-Way

(Curb Ramps)

Intersection ID: 21517	Main Street: BELLECHASSE_ST	Cross Street: COTILLION_AV	Location: SW
ADA ID: 4F725BAAAD5E	Ramp Type: BlendTrans1	Initial Pass/Fail: Fail	Overall Compliance: No
			Severity Score: 21.25

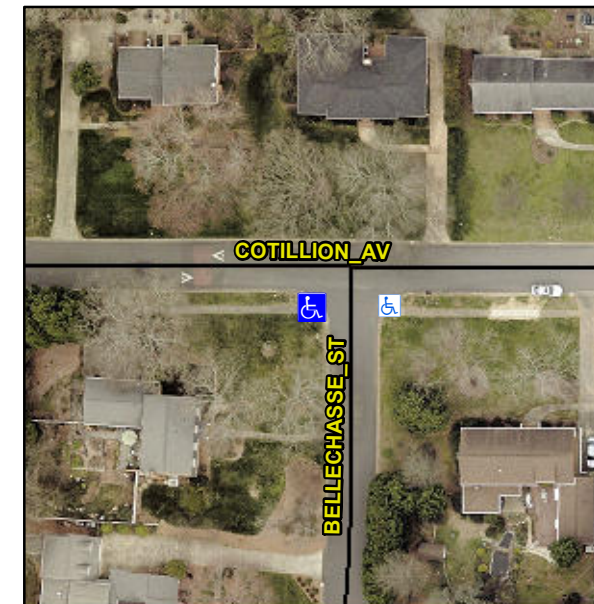
Not Found, R304.5.1, R304.5.3

Compliance	Description	Data	Compliance	Description	Data
N/A	Ramp Length (in)	57.0	Yes	BlendTrans Slope (%)	1.8
No	Ramp Width (in)	45.0	No	BlendTrans XSlope (%)	5.6
N/A	Flare Type LT	N/A	N/A	Flare Type RT	N/A
N/A	Flare Slope LT (%)	N/A	N/A	Flare Slope RT (%)	N/A
N/A	Flare Traversable LT?	N/A	N/A	Flare Traversable RT?	N/A
N/A	Landing Length (in)	N/A	N/A	DWS Provided?	N/A
N/A	Landing Width (in)	N/A	N/A	DWS Contrast?	N/A
N/A	Landing Slope (%)	N/A	N/A	DWS Length (in)	N/A
N/A	Landing X Slope (%)	N/A	N/A	DWS Full Width?	N/A
N/A	Landing Curb? (Y/N)	N/A	N/A	DWS Offset (in)	N/A
N/A	Shared Landing?	N/A			
N/A	Gutter Ponding?	N/A	N/A	Gutter Slope (%)	N/A
N/A	Gutter Lip Ht (in)	N/A	N/A	Gutter X Slope (%)	N/A
N/A	Painted X Walk1?	No	N/A	Painted X Walk2?	No
	X Walk 1 Direction	To E		X Walk 2 Direction	To N
	X Walk 1 Width (in)	N/A		X Walk 2 Width (in)	N/A
	X Walk 1 Slope (%)	6.3		X Walk 2 Slope (%)	0.9
	X Walk 1 X Slope (%)	0.3		X Walk 2 X Slope (%)	7.6

N/A	Ramp inside XWalk1?	N/A	N/A	Ramp inside XWalk2?	N/A
	Road Slope (%)	6.5		Clear Space?	N/A
	Road X Slope (%)	4.0	N/A	Clear Space to XWalk (in)	N/A
N/A	Any Obstructions?	N/A	N/A	Storm Grate/Utility Hazard?	N/A
	Obstruction Type			Storm Grate/Utility Type	
		N/A			N/A
			Yes	Surface Condition? (G/P)	Good
			No	Curb Slope (%)	8.2

Remove & Replace Curb Ramp With Two New Directional Ramps or Equivalent.
