## Access Compliance Report Public Rights-of-Way (Curb Ramps)

Intersection ID: 52306 Main Street: IMPATIEN\_DR Cross Street: AMERIA\_RD Location: NW

ADA ID: 4F7916EEA40D Ramp Type: PerpDiag Initial Pass/Fail: Fail Overall Compliance: No Severity Score: 8.75

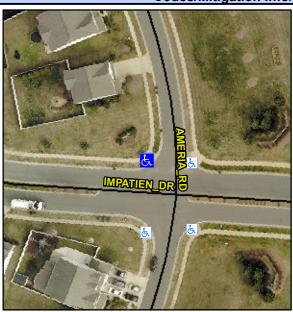
Comp	liance Description	Data	Comp	liance Description	Data
N/A	Ramp Length (in)	73.5	Yes	Ramp Slope (%)	5.5
No	Ramp Width (in)	46.5	Yes	Ramp XSlope (%)	1.7
N/A	Flare Type LT	N/A	N/A	Flare Type RT	N/A
N/A	Flare Slope LT (%)	N/A	N/A	Flare Slope RT (%)	N/A
N/A	Flare Traversable LT?	N/A	N/A	Flare Traversable RT?	N/A
N/A	Landing Length (in)	N/A	N/A	DWS Provided?	N/A
N/A	Landing Width (in)	N/A	N/A	DWS Contrast?	N/A
N/A	Landing Slope (%)	N/A	N/A	DWS Length (in)	N/A
N/A	Landing X Slope (%)	N/A	N/A	DWS Full Width?	N/A
N/A	Landing Curb? (Y/N)	N/A	N/A	DWS Offset (in)	N/A
N/A	Shared Landing?	N/A			
N/A	Gutter Ponding?	N/A	N/A	Gutter Slope (%)	N/A
N/A	Gutter Lip Ht (in)	N/A	N/A	Gutter X Slope (%)	N/A
N/A	Painted X Walk1?	No	N/A	Painted X Walk2?	No
	X Walk 1 Direction	To S		X Walk 2 Direction	To E
N/A	X Walk 1 Width (in)	N/A	N/A	X Walk 2 Width (in)	N/A
	X Walk 1 Slope (%)	2.0		X Walk 2 Slope (%)	0.8
	X Walk 1 X Slope (%)	0.4		X Walk 2 X Slope (%)	1.5

N/A	Ramp inside XWalk1?	N/A	N/A	Ramp inside XWalk2?	N/A
	Road Slope (%)	1.4	N/A	Clear Space?	N/A
	Road X Slope (%)	1.0	N/A	Clear Space to XWalk (in)	N/A
N/A	Any Obstructions?	N/A	N/A	Storm Grate/Utility Hazard?	N/A
	Obstruction Type		l	Storm Grate/Utility Type	
		N/A			N/A
			Yes	Surface Condition? (G/P)	Good

Possible Solution	
Possible Solutions:	9
Remove & Replace Curb Ramp With	N
Two New Directional Ramps or	ı
Equivalent.	N
	ı
	1
	1
Surveyor Notes:	1
N/A	1
	1
	1
	1
PROW/ADA:	1
Not Found, R304.5.1	N
	ı
	ı

Total Cost: \$ 3200.00
