Access Compliance Report

Public Rights-of-Way

(Curb Ramps)

| Intersection ID: 12517 | Main Street: N_SHARON_AMITY_RD | Cross Street: SHAMROCK_DR | Location: W |

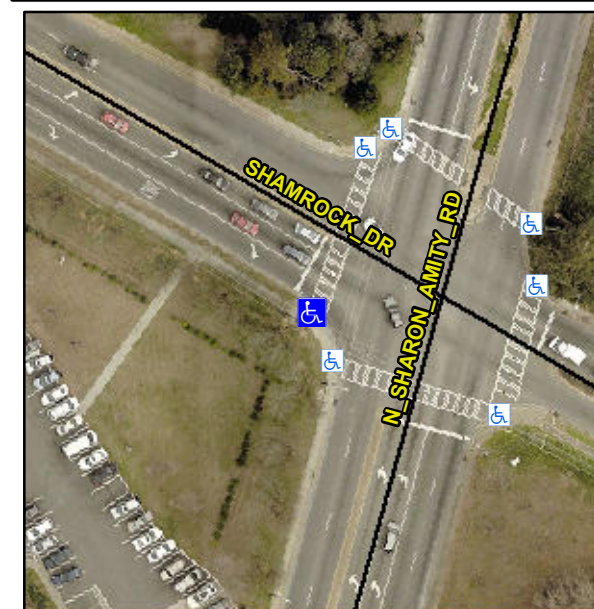
| ADA ID: 4F7A0EFBAA38 | Ramp Type: Perp | Initial Pass/Fail: Fail | Overall Compliance: No |
| Severity Score: 8.75 | | | |

Not Found, R304.5.1

| Compliance | Description | Data | Compliance | Description | Data |
|---|---|---|---|---|---|
| No | Ramp Width (in) | 47.0 | Yes | Ramp XSlope (%) | 0.2 |

Possible Solutions:

Remove & Replace Entire Ramp.

Total Cost: \$ 1850.00
