# Access Compliance Report

## Public Rights-of-Way

### (Curb Ramps)

Intersection ID: 43642	Main Street: CEDAR_CROSSINGS_DR	Cross Street: HUNTINGTON_MEADOW_LN	Location: NW
ADA ID: 4F9F5C9F7481	Ramp Type: PerpDiag	Initial Pass/Fail: Fail	Overall Compliance: No
		Severity Score: 10

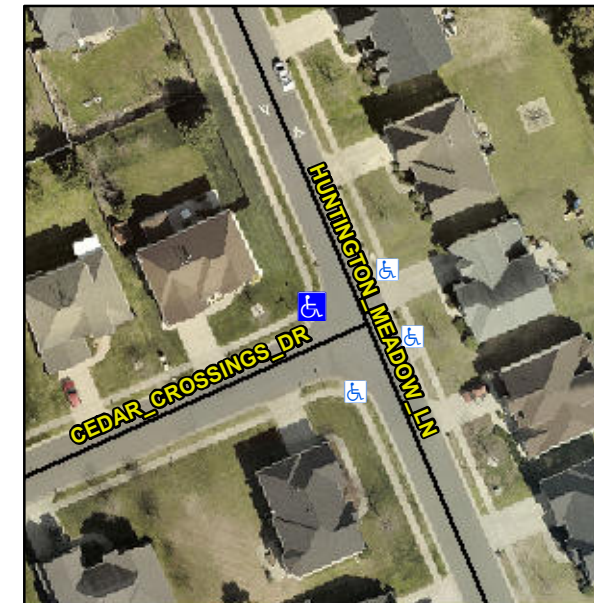
Compliance	Description	Data	Compliance	Description	Data
N/A	Ramp Length (in)	94.0	Yes	Ramp Slope (%)	6.1
No	Ramp Width (in)	40.0	No	Ramp XSlope (%)	4.7
N/A	Flare Type LT	N/A	N/A	Flare Type RT	N/A
N/A	Flare Slope LT (%)	N/A	N/A	Flare Slope RT (%)	N/A
N/A	Flare Traversable LT?	N/A	N/A	Flare Traversable RT?	N/A
N/A	Landing Length (in)	N/A	N/A	DWS Provided?	N/A
N/A	Landing Width (in)	N/A	N/A	DWS Contrast?	N/A
N/A	Landing Slope (%)	N/A	N/A	DWS Length (in)	N/A
N/A	Landing X Slope (%)	N/A	N/A	DWS Full Width?	N/A
N/A	Landing Curb? (Y/N)	N/A	N/A	DWS Offset (in)	N/A
N/A	Shared Landing?	N/A			
N/A	Gutter Ponding?	N/A	N/A	Gutter Slope (%)	N/A
N/A	Gutter Lip Ht (in)	N/A	N/A	Gutter X Slope (%)	N/A
N/A	Painted X Walk1?	No	N/A	Painted X Walk2?	No
	X Walk 1 Direction	To S		X Walk 2 Direction	To E
N/A	X Walk 1 Width (in)	N/A	N/A	X Walk 2 Width (in)	N/A
	X Walk 1 Slope (%)	2.9		X Walk 2 Slope (%)	4.7
	X Walk 1 X Slope (%)	0.8		X Walk 2 X Slope (%)	1.5

N/A	Ramp inside XWalk1?	N/A	N/A	Ramp inside XWalk2?	N/A
	Road Slope (%)	3.7	N/A	Clear Space?	N/A
	Road X Slope (%)	1.8	N/A	Clear Space to XWalk (in)	N/A
N/A	Any Obstructions?	N/A	N/A	Storm Grate/Utility Hazard?	N/A
	Obstruction Type			Storm Grate/Utility Type	
		N/A			N/A
		Yes		Surface Condition? (G/P)	Good

**Remove & Replace Curb Ramp With Two New Directional Ramps or Equivalent.**

**R304.5.1, R304.5.3**
