Access Compliance Report

Public Rights-of-Way

(Curb Ramps)

Intersection ID: 50269	Main Street: SOUTH_BV	Cross Street: HARTFORD_AV	Location: NE
ADA ID: 4F9FB79A4480	Ramp Type: Perp	Initial Pass/Fail: Fail	Overall Compliance: No
Severity Score: 10			
Codes/Mitigation Info/Possible Solution		Field Measurements/Component Compliance

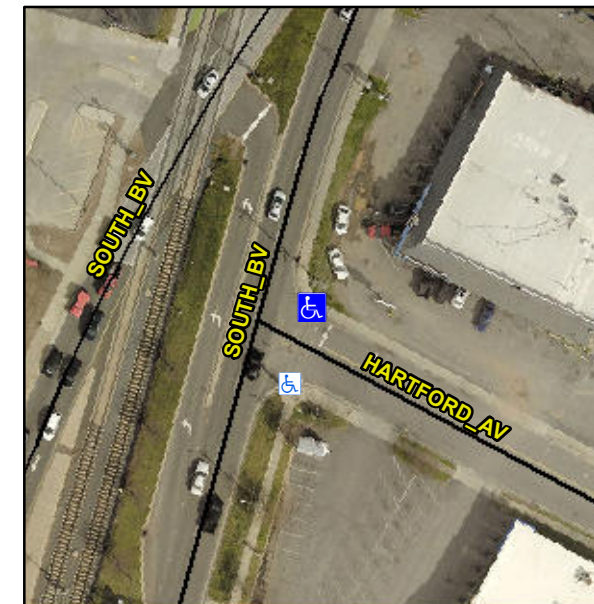
Not Found, R304.5.1, R304.5.3

Compliance	Description	Data	Compliance	Description	Data
N/A	Ramp Length (in)	72.0	Yes	Ramp Slope (%)	7.6
No	Ramp Width (in)	47.0	No	Ramp XSlope (%)	2.4
N/A	Flare Type LT	N/A	N/A	Flare Type RT	N/A
N/A	Flare Slope LT (%)	N/A	N/A	Flare Slope RT (%)	N/A
N/A	Flare Traversable LT?	N/A	N/A	Flare Traversable RT?	N/A
N/A	Landing Length (in)	N/A	N/A	DWS Provided?	N/A
N/A	Landing Width (in)	N/A	N/A	DWS Contrast?	N/A
N/A	Landing Slope (%)	N/A	N/A	DWS Length (in)	N/A
N/A	Landing X Slope (%)	N/A	N/A	DWS Full Width?	N/A
N/A	Landing Curb? (Y/N)	N/A	N/A	DWS Offset (in)	N/A
N/A	Shared Landing?	N/A			
N/A	Gutter Ponding?	N/A	N/A	Gutter Slope (%)	N/A
N/A	Gutter Lip Ht (in)	N/A	N/A	Gutter X Slope (%)	N/A
N/A	Painted X Walk1?	No	N/A	Painted X Walk2?	N/A
	X Walk 1 Direction	To SW		X Walk 2 Direction	N/A
N/A	X Walk 1 Width (in)	N/A	N/A	X Walk 2 Width (in)	N/A
	X Walk 1 Slope (%)	0.4		X Walk 2 Slope (%)	N/A
	X Walk 1 X Slope (%)	0.7		X Walk 2 X Slope (%)	N/A

N/A	Ramp inside XWalk1?	N/A	N/A	Ramp inside XWalk2?	N/A
	Road Slope (%)	N/A	N/A	Clear Space?	N/A
	Road X Slope (%)	N/A	N/A	Clear Space to XWalk (in)	N/A
N/A	Any Obstructions?	N/A	N/A	Storm Grate/Utility Hazard?	N/A
	Obstruction Type			Storm Grate/Utility Type	
		N/A			N/A
			Yes	Surface Condition? (G/P)	Good

Remove & Replace Entire Ramp.

Total Cost: \$ 1850.00
