Access Compliance Report

Public Rights-of-Way

(Curb Ramps)

Intersection ID: N/A	Main Street: RIDGEMORE_DR	Cross Street: OAK_GLEN_LN	Location: NE
ADA ID: 4FA7862C79FD	Ramp Type: PerpDiag	Initial Pass/Fail: Fail	Overall Compliance: No
		Severity Score: 25

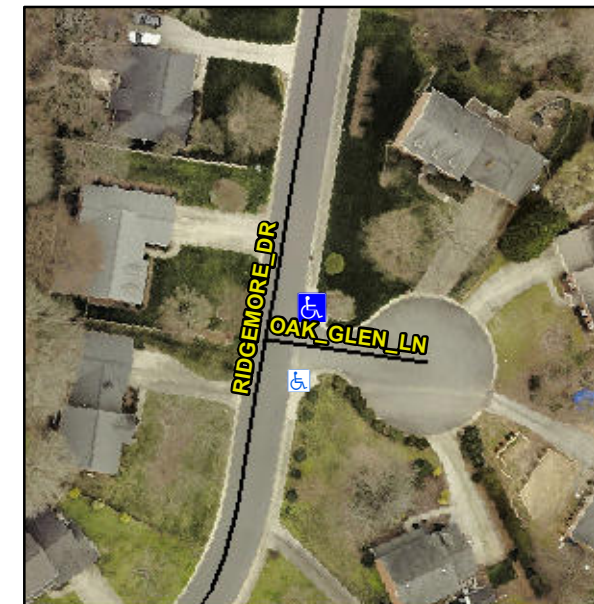
Not Found, R304.5.3

Compliance	Description	Data	Compliance	Description	Data
N/A	Ramp Length (in)	55.0	Yes	Ramp Slope (%)	6.8
Yes	Ramp Width (in)	48.0	No	Ramp XSlope (%)	9.8
N/A	Flare Type LT	N/A	N/A	Flare Type RT	N/A
N/A	Flare Slope LT (%)	N/A	N/A	Flare Slope RT (%)	N/A
N/A	Flare Traversable LT?	N/A	N/A	Flare Traversable RT?	N/A
N/A	Landing Length (in)	N/A	N/A	DWS Provided?	N/A
N/A	Landing Width (in)	N/A	N/A	DWS Contrast?	N/A
N/A	Landing Slope (%)	N/A	N/A	DWS Length (in)	N/A
N/A	Landing X Slope (%)	N/A	N/A	DWS Full Width?	N/A
N/A	Landing Curb? (Y/N)	N/A	N/A	DWS Offset (in)	N/A
N/A	Shared Landing?	N/A			
N/A	Gutter Ponding?	N/A	N/A	Gutter Slope (%)	N/A
N/A	Gutter Lip Ht (in)	N/A	N/A	Gutter X Slope (%)	N/A
N/A	Painted X Walk1?	No	N/A	Painted X Walk2?	No
	X Walk 1 Direction	To W		X Walk 2 Direction	To S
N/A	X Walk 1 Width (in)	N/A	N/A	X Walk 2 Width (in)	N/A
	X Walk 1 Slope (%)	1.3		X Walk 2 Slope (%)	3.2
	X Walk 1 X Slope (%)	3.4		X Walk 2 X Slope (%)	7.3

N/A	Ramp inside XWalk1?	N/A	N/A	Ramp inside XWalk2?	N/A
	Road Slope (%)	8.3	N/A	Clear Space?	N/A
	Road X Slope (%)	1.0	N/A	Clear Space to XWalk (in)	N/A
N/A	Any Obstructions?	N/A	N/A	Storm Grate/Utility Hazard?	N/A
	Obstruction Type			Storm Grate/Utility Type	
		N/A			N/A
		Yes		Surface Condition? (G/P)	Good

Remove & Replace Curb Ramp With Two New Directional Ramps or Equivalent.

Total Cost: \$ 3200.00
