Access Compliance Report

Public Rights-of-Way

(Curb Ramps)

Intersection ID: 11278	Main Street: DELGANY_DR	Cross Street: FOXFORD_PL	Location: SW
ADA ID: 4FBB7E4886E5	Ramp Type: BlendTrans1	Initial Pass/Fail: Fail	Overall Compliance: No
			Severity Score: 21.25

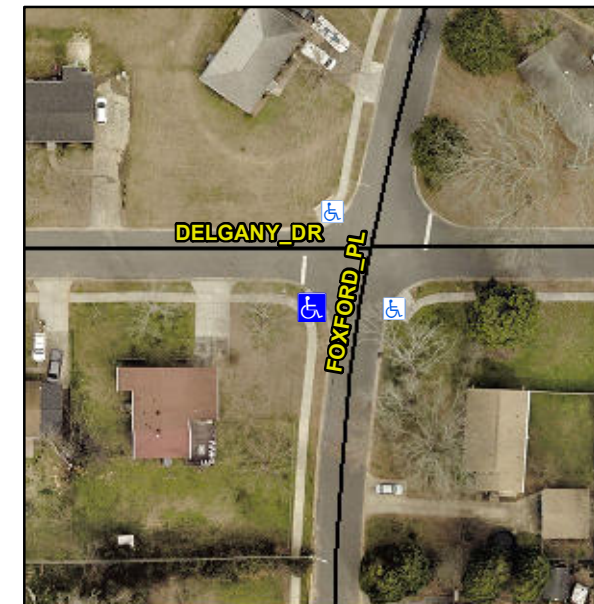
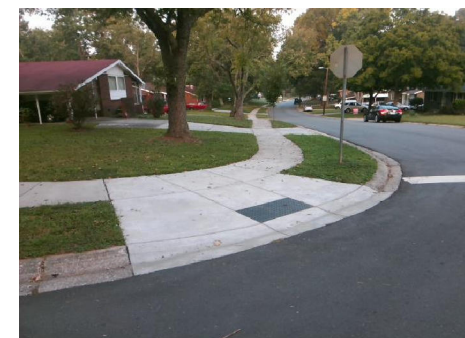
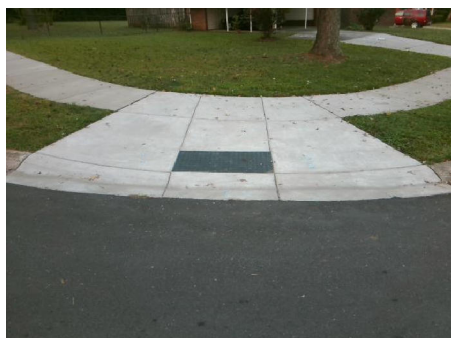
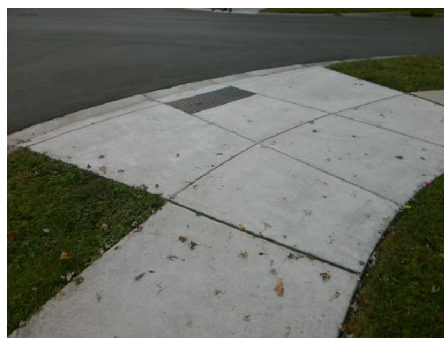
Not Found, R304.5.1, R304.5.3

Compliance	Description	Data	Compliance	Description	Data
N/A	Ramp Length (in)	72.0	Yes	BlendTrans Slope (%)	4.6
No	Ramp Width (in)	47.0	No	BlendTrans XSlope (%)	5.4
N/A	Flare Type LT	N/A	N/A	Flare Type RT	N/A
N/A	Flare Slope LT (%)	N/A	N/A	Flare Slope RT (%)	N/A
N/A	Flare Traversable LT?	N/A	N/A	Flare Traversable RT?	N/A
N/A	Landing Length (in)	N/A	N/A	DWS Provided?	N/A
N/A	Landing Width (in)	N/A	N/A	DWS Contrast?	N/A
N/A	Landing Slope (%)	N/A	N/A	DWS Length (in)	N/A
N/A	Landing X Slope (%)	N/A	N/A	DWS Full Width?	N/A
N/A	Landing Curb? (Y/N)	N/A	N/A	DWS Offset (in)	N/A
N/A	Shared Landing?	N/A			
N/A	Gutter Ponding?	N/A	N/A	Gutter Slope (%)	N/A
N/A	Gutter Lip Ht (in)	N/A	N/A	Gutter X Slope (%)	N/A
N/A	Painted X Walk1?	No	N/A	Painted X Walk2?	No
	X Walk 1 Direction	To E		X Walk 2 Direction	To N
	X Walk 1 Width (in)	N/A		X Walk 2 Width (in)	N/A
	X Walk 1 Slope (%)	1.7		X Walk 2 Slope (%)	0.8
	X Walk 1 X Slope (%)	1.4		X Walk 2 X Slope (%)	3.3

N/A	Ramp inside XWalk1?	N/A	N/A	Ramp inside XWalk2?	N/A
	Road Slope (%)	4.4		Clear Space?	N/A
	Road X Slope (%)	1.9	N/A	Clear Space to XWalk (in)	N/A
N/A	Any Obstructions?	N/A	N/A	Storm Grate/Utility Hazard?	N/A
	Obstruction Type			Storm Grate/Utility Type	
		N/A			N/A
			Yes	Surface Condition? (G/P)	Good
			No	Curb Slope (%)	17.9

Remove & Replace Curb Ramp With Two New Directional Ramps or Equivalent.
