# Access Compliance Report

## Public Rights-of-Way

### (Curb Ramps)

Intersection ID: 19845	Main Street: CECILIA_LN	Cross Street: KELBURN_LN	Location:	N
ADA ID: 4FC14C3D3C5F	Ramp Type: PerpDiag	Initial Pass/Fail: Fail	Overall Compliance: No	Severity Score: 8.75
Codes/Mitigation Info/Possible Solution		Field Measurements/Component Compliance

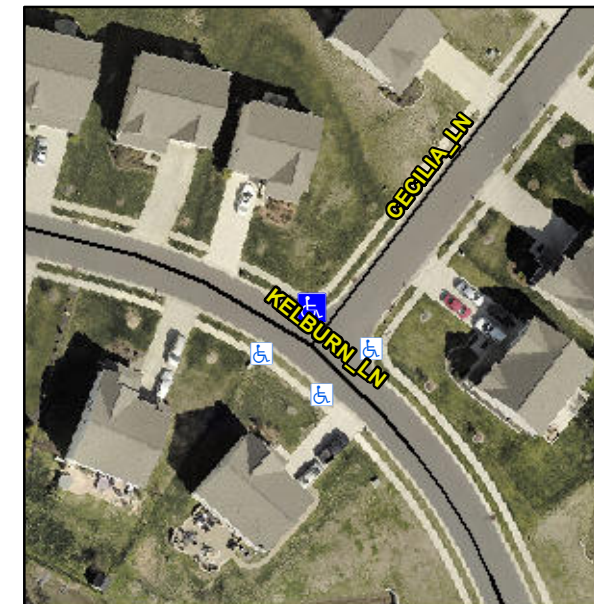
**Not Found, R304.5.1**

Compliance	Description	Data	Compliance	Description	Data
N/A	Ramp Length (in)	52.0	Yes	Ramp Slope (%)	6.1
No	Ramp Width (in)	47.0	Yes	Ramp XSlope (%)	0.3
N/A	Flare Type LT	N/A	N/A	Flare Type RT	N/A
N/A	Flare Slope LT (%)	N/A	N/A	Flare Slope RT (%)	N/A
N/A	Flare Traversable LT?	N/A	N/A	Flare Traversable RT?	N/A
N/A	Landing Length (in)	N/A	N/A	DWS Provided?	N/A
N/A	Landing Width (in)	N/A	N/A	DWS Contrast?	N/A
N/A	Landing Slope (%)	N/A	N/A	DWS Length (in)	N/A
N/A	Landing X Slope (%)	N/A	N/A	DWS Full Width?	N/A
N/A	Landing Curb? (Y/N)	N/A	N/A	DWS Offset (in)	N/A
N/A	Shared Landing?	N/A			
N/A	Gutter Ponding?	N/A	N/A	Gutter Slope (%)	N/A
N/A	Gutter Lip Ht (in)	N/A	N/A	Gutter X Slope (%)	N/A
N/A	Painted X Walk1?	No	N/A	Painted X Walk2?	No
	X Walk 1 Direction	To SW		X Walk 2 Direction	To SE
N/A	X Walk 1 Width (in)	N/A	N/A	X Walk 2 Width (in)	N/A
	X Walk 1 Slope (%)	0.6		X Walk 2 Slope (%)	0.8
	X Walk 1 X Slope (%)	1.8		X Walk 2 X Slope (%)	0.2

N/A	Ramp inside XWalk1?	N/A	N/A	Ramp inside XWalk2?	N/A
	Road Slope (%)	1.7	N/A	Clear Space?	N/A
	Road X Slope (%)	1.5	N/A	Clear Space to XWalk (in)	N/A
N/A	Any Obstructions?	N/A	N/A	Storm Grate/Utility Hazard?	N/A
	Obstruction Type			Storm Grate/Utility Type	
		N/A			N/A
			Yes	Surface Condition? (G/P)	Good

Possible Solutions:

**Remove & Replace Curb Ramp With Two New Directional Ramps or Equivalent.**
