Access Compliance Report

Public Rights-of-Way

(Curb Ramps)

Intersection ID: 28629	Main Street: DEARMON_RD	Cross Street: EAGLE_CREEK_DR	Location: S
ADA ID: 4FC1F1D24847	Ramp Type: Perp	Initial Pass/Fail: Fail	Overall Compliance: No
Severity Score: 21.25			
Codes/Mitigation Info/Possible Solution		Field Measurements/Component Compliance

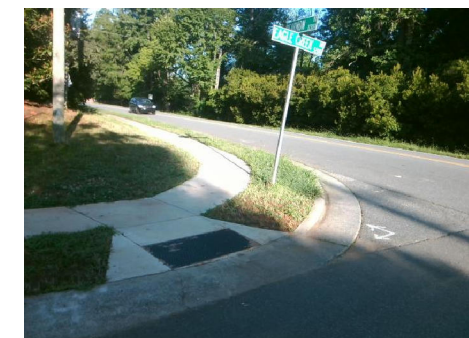
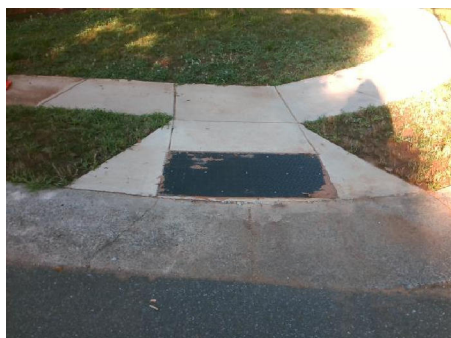
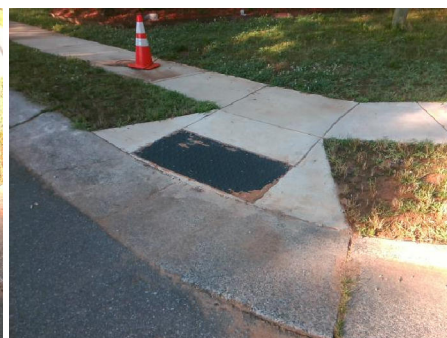
R304.5.1, R304.2.2

Compliance	Description	Data	Compliance	Description	Data
N/A	Ramp Length (in)	48.0	No	Ramp Slope (%)	8.8
No	Ramp Width (in)	46.0	Yes	Ramp XSlope (%)	2.0
N/A	Flare Type LT	N/A	N/A	Flare Type RT	N/A
N/A	Flare Slope LT (%)	N/A	N/A	Flare Slope RT (%)	N/A
N/A	Flare Traversable LT?	N/A	N/A	Flare Traversable RT?	N/A
N/A	Landing Length (in)	N/A	N/A	DWS Provided?	N/A
N/A	Landing Width (in)	N/A	N/A	DWS Contrast?	N/A
N/A	Landing Slope (%)	N/A	N/A	DWS Length (in)	N/A
N/A	Landing X Slope (%)	N/A	N/A	DWS Full Width?	N/A
N/A	Landing Curb? (Y/N)	N/A	N/A	DWS Offset (in)	N/A
N/A	Shared Landing?	N/A			
N/A	Gutter Ponding?	N/A	N/A	Gutter Slope (%)	N/A
N/A	Gutter Lip Ht (in)	N/A	N/A	Gutter X Slope (%)	N/A
N/A	Painted X Walk1?	No	N/A	Painted X Walk2?	N/A
	X Walk 1 Direction	To NE		X Walk 2 Direction	N/A
N/A	X Walk 1 Width (in)	N/A	N/A	X Walk 2 Width (in)	N/A
	X Walk 1 Slope (%)	4.1		X Walk 2 Slope (%)	N/A
	X Walk 1 X Slope (%)	0.0		X Walk 2 X Slope (%)	N/A

N/A	Ramp inside XWalk1?	N/A	N/A	Ramp inside XWalk2?	N/A
	Road Slope (%)	N/A	N/A	Clear Space?	N/A
	Road X Slope (%)	N/A	N/A	Clear Space to XWalk (in)	N/A
N/A	Any Obstructions?	N/A	N/A	Storm Grate/Utility Hazard?	N/A
	Obstruction Type			Storm Grate/Utility Type	
		N/A			N/A
			Yes	Surface Condition? (G/P)	Good

Possible Solutions:

Remove & Replace Entire Ramp.

Total Cost: \$ 1850.00
