# Access Compliance Report

## Public Rights-of-Way

### (Curb Ramps)

Intersection ID: 17498	Main Street: BAINBRIDGE_RD	Cross Street: KNICKERBOCKER_DR	Location: W
ADA ID: 4FC980A852A9	Ramp Type: Directional1	Initial Pass/Fail: Fail	Overall Compliance: No
Severity Score: 1.25			
Codes/Mitigation Info/Possible Solution		Field Measurements/Component Compliance

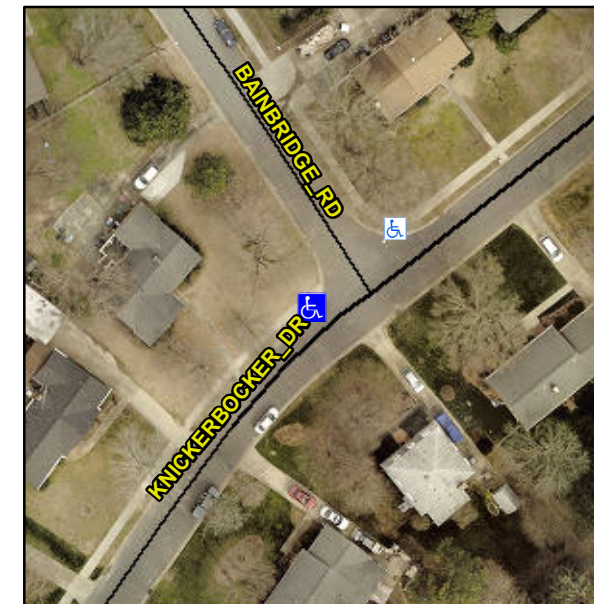
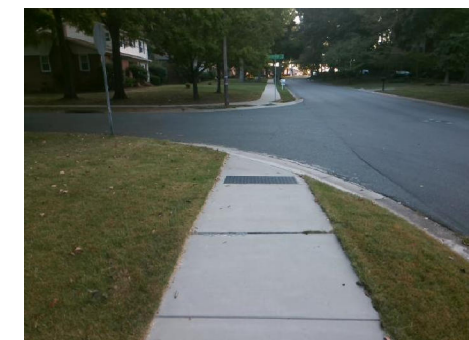
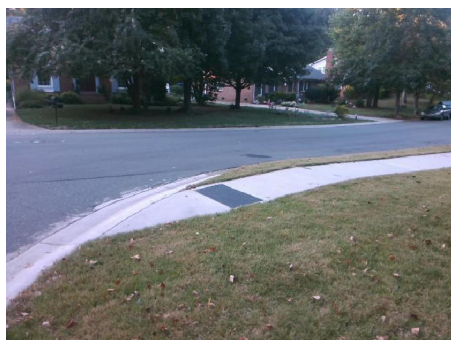
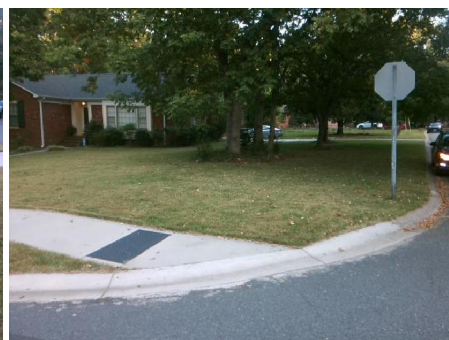
Compliance	Description	Data	Compliance	Description	Data
N/A	Ramp Length (in)	106.0	N/A	Grade Break?	N/A
Yes	Ramp Width (in)	60.0	N/A	Grade Break Slope (%)	0.0
Yes	Ramp Slope (%)	3.7	N/A	Grade Break XSlope (%)	0.0
No	Ramp XSlope (%)	2.9			
N/A	Flare Type LT	N/A	N/A	Flare Type RT	N/A
N/A	Flare Slope LT (%)	N/A	N/A	Flare Slope RT (%)	0.0
N/A	Flare Traversable LT?	N/A	N/A	Flare Traversable RT?	N/A
N/A	Landing Length (in)	0.0	N/A	DWS Provided?	N/A
N/A	Landing Width (in)	0.0	N/A	DWS Contrast?	N/A
N/A	Landing Slope (%)	0.0	N/A	DWS Length (in)	N/A
N/A	Landing X Slope (%)	0.0	N/A	DWS Full Width?	N/A
N/A	Landing Curb? (Y/N)	N/A	N/A	DWS Offset LT (in)	N/A
N/A	Shared Landing?	N/A	N/A	DWS Offset RT (in)	N/A
N/A	Gutter Ponding?	0.0	N/A	Gutter Slope (%)	N/A
N/A	Gutter Lip Ht (in)	0.0	N/A	Gutter X Slope (%)	N/A
N/A	Painted X Walk1?	No		Road Slope (%)	6.5
	X Walk 1 Direction	To NE		Road X Slope (%)	3.5
	X Walk 1 Width (in)	N/A		Clear Space?	N/A

X Walk 1 Slope (%)	6.5	N/A	Clear Space to XWalk (in)	N/A
	X Walk 1 X Slope (%)	3.5	N/A	Storm Grate/Utility Hazard?	N/A
N/A	Ramp inside XWalk1?	N/A		Storm Grate/Utility Type	
N/A	Any Obstructions?	N/A			N/A
	Obstruction Type		Yes	Surface Condition? (G/P)	Good
			N/A	Curb Slope (%)	23.4

Possible Solutions:

**Remove & Replace Entire Ramp.**

PROW/ADA:

**R304.5.3**
