Access Compliance Report

Public Rights-of-Way

(Curb Ramps)

Intersection ID: 3026	Main Street: FOX_HILL_DR	Cross Street: FOX_TROT_DR	Location:	N
ADA ID: 4FE675C7A3C1	Ramp Type: Perp	Initial Pass/Fail: Fail	Overall Compliance: No	Severity Score: 1.25
Codes/Mitigation Info/Possible Solution		Field Measurements/Component Compliance

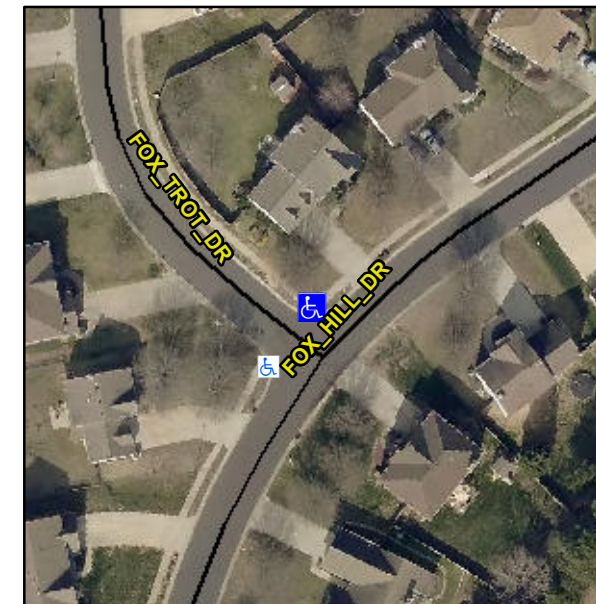
PROW/ADA:

Not Found, R304.5.3

Compliance	Description	Data	Compliance	Description	Data
N/A	Ramp Length (in)	64.0	Yes	Ramp Slope (%)	5.0
Yes	Ramp Width (in)	48.0	No	Ramp XSlope (%)	2.2
N/A	Flare Type LT	N/A	N/A	Flare Type RT	N/A
N/A	Flare Slope LT (%)	N/A	N/A	Flare Slope RT (%)	N/A
N/A	Flare Traversable LT?	N/A	N/A	Flare Traversable RT?	N/A
N/A	Landing Length (in)	N/A	N/A	DWS Provided?	N/A
N/A	Landing Width (in)	N/A	N/A	DWS Contrast?	N/A
N/A	Landing Slope (%)	N/A	N/A	DWS Length (in)	N/A
N/A	Landing X Slope (%)	N/A	N/A	DWS Full Width?	N/A
N/A	Landing Curb? (Y/N)	N/A	N/A	DWS Offset (in)	N/A
N/A	Shared Landing?	N/A			
N/A	Gutter Ponding?	N/A	N/A	Gutter Slope (%)	N/A
N/A	Gutter Lip Ht (in)	N/A	N/A	Gutter X Slope (%)	N/A
N/A	Painted X Walk1?	No	N/A	Painted X Walk2?	N/A
	X Walk 1 Direction	To SW		X Walk 2 Direction	N/A
N/A	X Walk 1 Width (in)	N/A	N/A	X Walk 2 Width (in)	N/A
	X Walk 1 Slope (%)	1.6		X Walk 2 Slope (%)	N/A
	X Walk 1 X Slope (%)	1.4		X Walk 2 X Slope (%)	N/A

N/A	Ramp inside XWalk1?	N/A	N/A	Ramp inside XWalk2?	N/A
	Road Slope (%)	N/A	N/A	Clear Space?	N/A
	Road X Slope (%)	N/A	N/A	Clear Space to XWalk (in)	N/A
N/A	Any Obstructions?	N/A	N/A	Storm Grate/Utility Hazard?	N/A
	Obstruction Type			Storm Grate/Utility Type	
		N/A			N/A
			Yes	Surface Condition? (G/P)	Good

Possible Solutions:

Remove & Replace Entire Ramp.

Total Cost: \$ 1850.00
