# Access Compliance Report

## Public Rights-of-Way

### (Curb Ramps)

Intersection ID: 53886	Main Street: PAW_VALLEY_LN	Cross Street: N/A	Location: SW
ADA ID: 4FF3F8BE646E	Ramp Type: PerpDiag	Initial Pass/Fail: Fail	Overall Compliance: No
Codes/Mitigation Info/Possible Solution		Field Measurements/Component Compliance	
Severity Score: 8.75

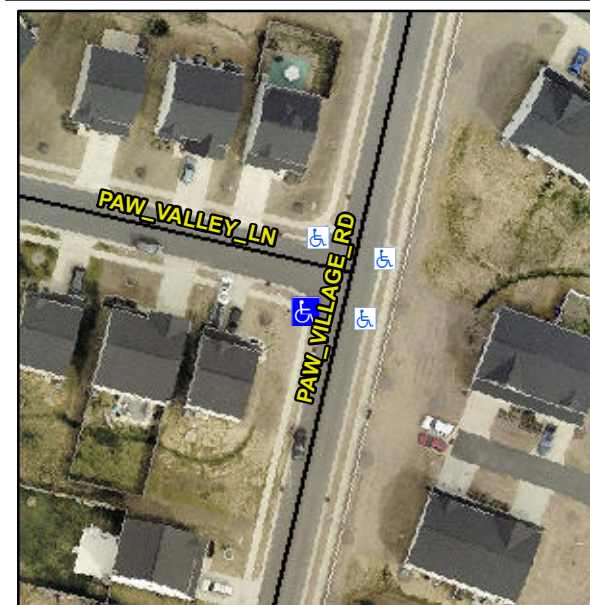
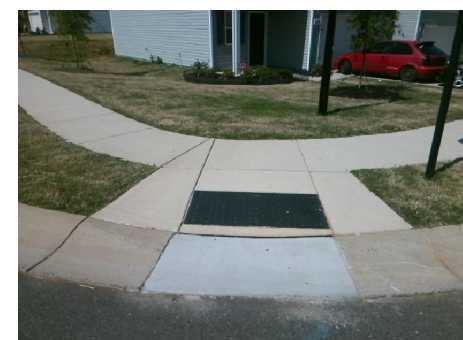
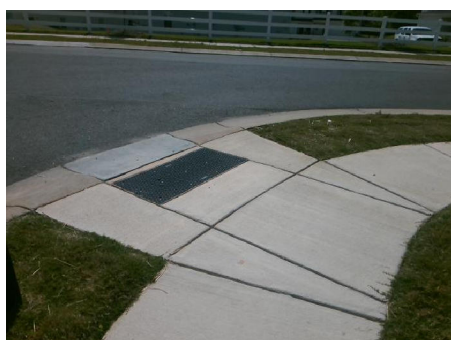
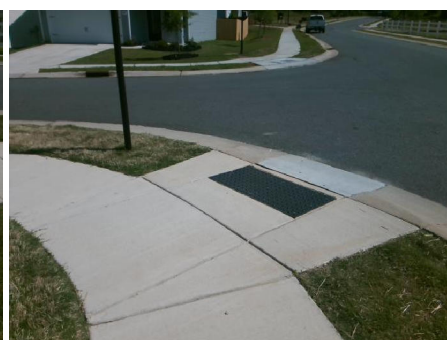
**Not Found, R304.5.1**

Compliance	Description	Data	Compliance	Description	Data
N/A	Ramp Length (in)	50.0	Yes	Ramp Slope (%)	5.6
No	Ramp Width (in)	47.0	Yes	Ramp XSlope (%)	1.4
N/A	Flare Type LT	N/A	N/A	Flare Type RT	N/A
N/A	Flare Slope LT (%)	N/A	N/A	Flare Slope RT (%)	N/A
N/A	Flare Traversable LT?	N/A	N/A	Flare Traversable RT?	N/A
N/A	Landing Length (in)	N/A	N/A	DWS Provided?	N/A
N/A	Landing Width (in)	N/A	N/A	DWS Contrast?	N/A
N/A	Landing Slope (%)	N/A	N/A	DWS Length (in)	N/A
N/A	Landing X Slope (%)	N/A	N/A	DWS Full Width?	N/A
N/A	Landing Curb? (Y/N)	N/A	N/A	DWS Offset (in)	N/A
N/A	Shared Landing?	N/A			
N/A	Gutter Ponding?	N/A	N/A	Gutter Slope (%)	N/A
N/A	Gutter Lip Ht (in)	N/A	N/A	Gutter X Slope (%)	N/A
N/A	Painted X Walk1?	No	N/A	Painted X Walk2?	No
	X Walk 1 Direction	To E		X Walk 2 Direction	To N
N/A	X Walk 1 Width (in)	N/A	N/A	X Walk 2 Width (in)	N/A
	X Walk 1 Slope (%)	5.4		X Walk 2 Slope (%)	3.6
	X Walk 1 X Slope (%)	3.4		X Walk 2 X Slope (%)	5.6

N/A	Ramp inside XWalk1?	N/A	N/A	Ramp inside XWalk2?	N/A
	Road Slope (%)	1.1	N/A	Clear Space?	N/A
	Road X Slope (%)	6.6	N/A	Clear Space to XWalk (in)	N/A
N/A	Any Obstructions?	N/A	N/A	Storm Grate/Utility Hazard?	N/A
	Obstruction Type			Storm Grate/Utility Type	
		N/A			N/A
			Yes	Surface Condition? (G/P)	Good

**Remove & Replace Curb Ramp With Two New Directional Ramps or Equivalent.**
