Access Compliance Report

Public Rights-of-Way

(Curb Ramps)

Intersection ID: 43362	Main Street: PROSPERITY_VIEW_DR	Cross Street: RIDGE_RD	Location: NE
ADA ID: 4FFE3BEE15CE	Ramp Type: Perp	Initial Pass/Fail: Pass	Overall Compliance: No
Severity Score: 2.5			
Codes/Mitigation Info/Possible Solution		Field Measurements/Component Compliance

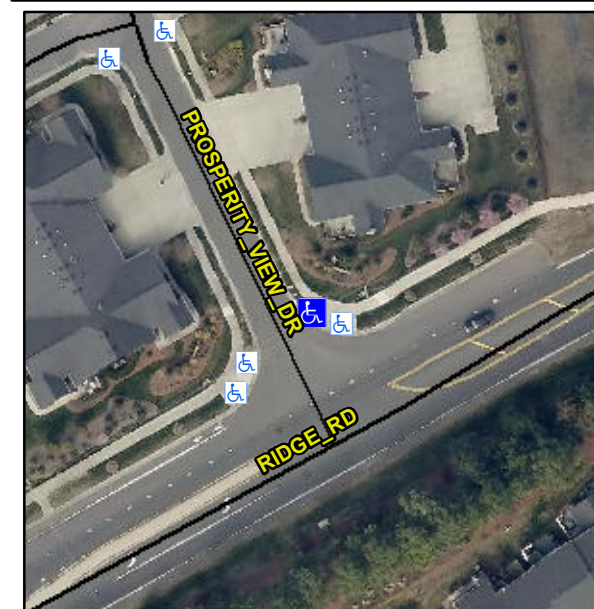
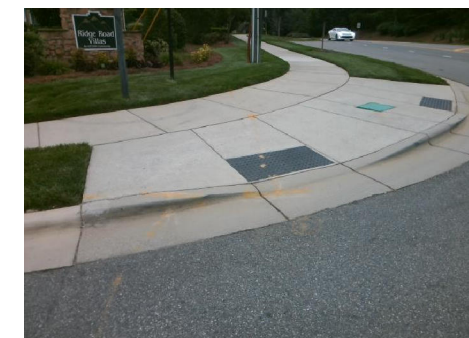
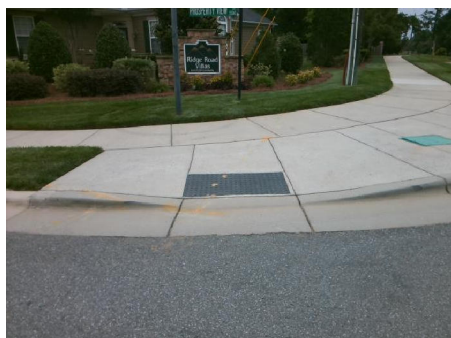
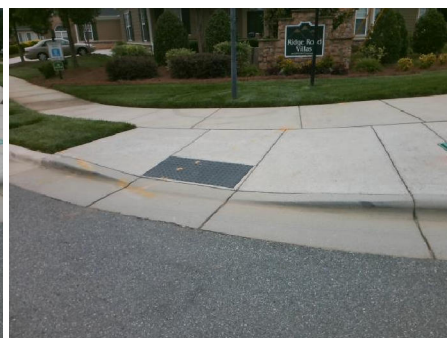
Compliance	Description	Data	Compliance	Description	Data
N/A	Ramp Length (in)	72.0	Yes	Ramp Slope (%)	7.7
Yes	Ramp Width (in)	48.0	Yes	Ramp XSlope (%)	1.1
N/A	Flare Type LT	Sloped	N/A	Flare Type RT	N/A
N/A	Flare Slope LT (%)	8.1	Yes	Flare Slope RT (%)	8.2
N/A	Flare Traversable LT?	Yes	N/A	Flare Traversable RT?	Yes
Yes	Landing Length (in)	67.0	Yes	DWS Provided?	Yes
Yes	Landing Width (in)	63.0	Yes	DWS Contrast?	Yes
Yes	Landing Slope (%)	1.3	Yes	DWS Length (in)	24.0
Yes	Landing X Slope (%)	2.0	No	DWS Full Width?	No
N/A	Landing Curb? (Y/N)	No	Yes	DWS Offset (in)	2.0
N/A	Shared Landing?	No			
Yes	Gutter Ponding?	No	Yes	Gutter Slope (%)	2.2
Yes	Gutter Lip Ht (in)	0.0	No	Gutter X Slope (%)	2.5
N/A	Painted X Walk1?	No	N/A	Painted X Walk2?	N/A
	X Walk 1 Direction	To SW		X Walk 2 Direction	N/A
N/A	X Walk 1 Width (in)	N/A	N/A	X Walk 2 Width (in)	N/A
	X Walk 1 Slope (%)	0.1		X Walk 2 Slope (%)	N/A
	X Walk 1 X Slope (%)	1.7		X Walk 2 X Slope (%)	N/A

N/A	Ramp inside XWalk1?	N/A	N/A	Ramp inside XWalk2?	N/A
	Road Slope (%)	N/A	N/A	Clear Space?	Yes
	Road X Slope (%)	N/A	N/A	Clear Space to XWalk (in)	N/A
Yes	Any Obstructions?	No	Yes	Storm Grate/Utility Hazard?	No
	Obstruction Type			Storm Grate/Utility Type	
		N/A			N/A
			Yes	Surface Condition? (G/P)	Good

Possible Solutions:

Remove & Replace Detectable Warning System. Remove & Replace Gutter.

R305.1.4, R304.5.3
