Access Compliance Report Public Rights-of-Way (Curb Ramps)

0	0 1 1				1	
Intersection ID: 14901	Main Street: BALTIMORE_AV		Cross Street: FAIRWOOD_AV			Location: N			
ADA ID: 5011F72844DC	344DC Ramp Type: PerpDiag		Initial F	nitial Pass/Fail: Fail Overall Complian			nce: N	o Severity Score:	13.75
Codes/Mitigation Info/Possible Solution				Field Measurements/Component Compliance					
	ALL SALES	Possible Solutions:		Compliance Description		Data	Data Compliance Description		
		Remove & Replace Curb Ramp W	lith	N/A	Ramp Length (in)	53.0	No	Ramp Slope (%)	9.5
		Two New Directional Ramps or		Yes	Ramp Width (in)	48.0	No	Ramp XSlope (%)	4.5
		Equivalent.		N/A	Flare Type LT	N/A	N/A	Flare Type RT	N/A
				N/A	Flare Slope LT (%)	N/A	N/A	Flare Slope RT (%)	N/A
				N/A	Flare Traversable LT?	N/A	N/A	Flare Traversable RT?	N/A
A CONTRACT				N/A	Landing Length (in)	N/A	N/A	DWS Provided?	N/A
		Surveyor Notes:		N/A	Landing Width (in)	N/A	N/A	DWS Contrast?	N/A
the second second		N/A		N/A	Landing Slope (%)	N/A	N/A	DWS Length (in)	N/A

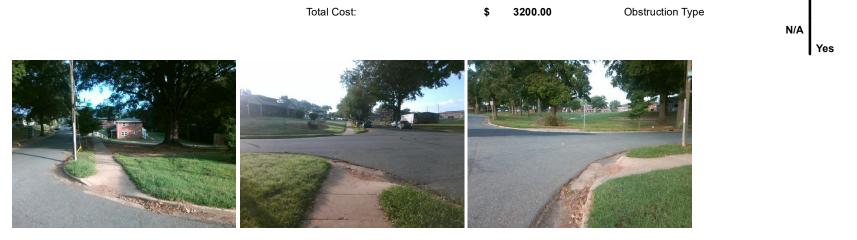
N/A	Landing X Slope (%)	N/A	N/A	DWS Full Width?	N/A
the second se	Car I The			N/A	Landing Curb? (Y/N)	N/A	N/A	DWS Offset (in)	N/A
	Kt/ A			N/A	Shared Landing?	N/A			
the second se	N. AL	PROW/ADA:		N/A	Gutter Ponding?	N/A	N/A	Gutter Slope (%)	N/A
	X	R304.2.2, R304.5.3		N/A	Gutter Lip Ht (in)	N/A	N/A	Gutter X Slope (%)	N/A
	the find the second	,		N/A	Painted X Walk1?	No	N/A	Painted X Walk2?	No
					X Walk 1 Direction	To SW		X Walk 2 Direction	To SE
				N/A	X Walk 1 Width (in)	N/A	N/A	X Walk 2 Width (in)	N/A
Street 1 Name	FAIRWOOD AV				X Walk 1 Slope (%)	5.9		X Walk 2 Slope (%)	6.1
Stop Condition-Street 2	StopSign				X Walk 1 X Slope (%)	4.7		X Walk 2 X Slope (%)	3.5
Street 2 Name	BALTIMORE AV			N/A	Ramp inside XWalk1?	N/A	N/A	Ramp inside XWalk2?	N/A
Stop Condition-Street 1	None				Road Slope (%)	1.2	N/A	Clear Space?	N/A
					Road X Slope (%)	7.6	N/A	Clear Space to XWalk (in)	N/A
				N/A	Any Obstructions?	N/A	N/A	Storm Grate/Utility Hazard?	N/A

Total Cost: \$ 32	200.00		Obstruction Type			Storm Grate/Utility Type	
						N/A			N/A
