Access Compliance Report

Public Rights-of-Way

(Curb Ramps)

Intersection ID: 5264	Main Street: BEATTIES_FORD_RD	Cross Street: MCINTYRE_AV	Location: SE
ADA ID: 501609139302	Ramp Type: Combination1	Initial Pass/Fail: Fail	Overall Compliance: No
Codes/Mitigation Info/Possible Solution			Severity Score: 22.5
			Field Measurements/Component Compliance

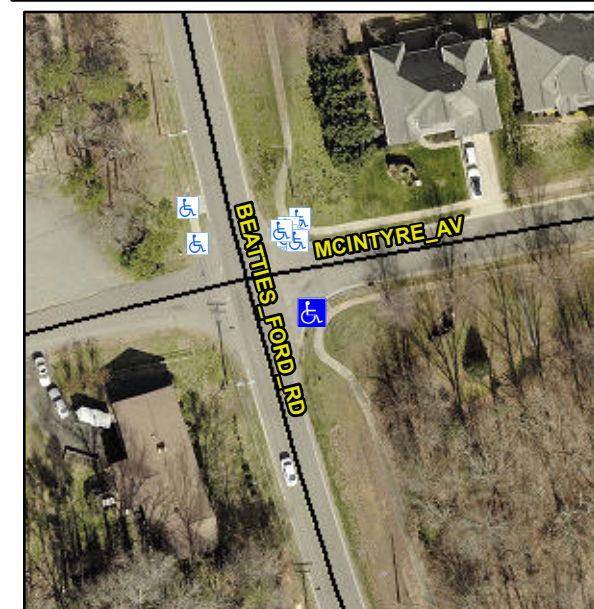
LT RP < 5%

Not Found, R304.5.1, R304.5.3, R304.3.2

Compliance	Description	Data	Compliance	Description	Data
N/A	Ramp Length LT (in)	52.0	N/A	Ramp Length RT (in)	50.5
Yes	Ramp Width LT (in)	51.5	Yes	Ramp Width RT (in)	54.0
Yes	Ramp Slope LT (%)	4.6	No	Ramp Slope RT (%)	8.4
No	Ramp XSlope LT (%)	3.2	Yes	Ramp XSlope RT (%)	0.9
N/A	Ramp Length (in)	52.0	Yes	Ramp Slope (%)	3.2
No	Ramp Width (in)	39.5	Yes	Ramp XSlope (%)	0.7
N/A	Flare Type LT	N/A	N/A	Flare Type RT	N/A
N/A	Flare Slope LT (%)	N/A	N/A	Flare Slope RT (%)	N/A
N/A	Flare Traversable LT?	N/A	N/A	Flare Traversable RT?	N/A
N/A	Landing Length (in)	N/A	N/A	DWS Provided?	N/A
N/A	Landing Width (in)	N/A	N/A	DWS Contrast?	N/A
N/A	Landing Slope (%)	N/A	N/A	DWS Length (in)	N/A
N/A	Landing X Slope (%)	N/A	N/A	DWS Full Width?	N/A
N/A	Landing Curb? (Y/N)	N/A	N/A	DWS Offset (in)	N/A
N/A	Shared Landing?	N/A			
N/A	Gutter Ponding?	N/A	N/A	Gutter Slope (%)	N/A
N/A	Gutter Lip Ht (in)	N/A	N/A	Gutter X Slope (%)	N/A
N/A	Painted X Walk1?	No	N/A	Painted X Walk2?	N/A

X Walk 1 Direction	To N		X Walk 2 Direction	N/A
	X Walk 1 Width (in)	N/A		X Walk 2 Width (in)	N/A
	X Walk 1 Slope (%)	2.2		X Walk 2 Slope (%)	N/A
	X Walk 1 X Slope (%)	0.7		X Walk 2 X Slope (%)	N/A
N/A	Ramp inside XWalk1?	N/A	N/A	Ramp inside XWalk2?	N/A
	Road Slope (%)	N/A		Clear Space?	N/A
	Road X Slope (%)	N/A	N/A	Clear Space to XWalk (in)	N/A
			N/A	Any Obstruction?	N/A
				Obstruction Type	N/A
			N/A	Storm Grate/Utility Hazard?	N/A
				Storm Grate/Utility Type	N/A
			Yes	Surface Condition? (G/P)	Good
				Curb Slope (%)	9.2

Possible Solutions:

Remove & Replace Entire Ramp.
