Access Compliance Report

Public Rights-of-Way

(Curb Ramps)

Intersection ID: 30548	Main Street: SOUTH_BV	Cross Street: CAROLINA_PAVILION_DR_S	Location: SW
ADA ID: 50191B8DD427	Ramp Type: Perp	Initial Pass/Fail: Fail	Overall Compliance: No
		Severity Score: 22.5

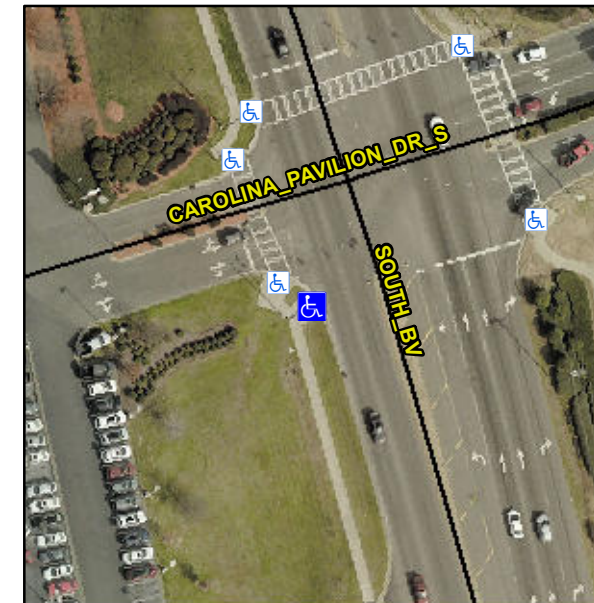
Not Found, R304.5.1, R304.2.2, R304.5.3

Compliance	Description	Data	Compliance	Description	Data
N/A	Ramp Length (in)	132.0	No	Ramp Slope (%)	8.8
No	Ramp Width (in)	47.0	No	Ramp XSlope (%)	4.0
N/A	Flare Type LT	N/A	N/A	Flare Type RT	N/A
N/A	Flare Slope LT (%)	N/A	N/A	Flare Slope RT (%)	N/A
N/A	Flare Traversable LT?	N/A	N/A	Flare Traversable RT?	N/A
N/A	Landing Length (in)	N/A	N/A	DWS Provided?	N/A
N/A	Landing Width (in)	N/A	N/A	DWS Contrast?	N/A
N/A	Landing Slope (%)	N/A	N/A	DWS Length (in)	N/A
N/A	Landing X Slope (%)	N/A	N/A	DWS Full Width?	N/A
N/A	Landing Curb? (Y/N)	N/A	N/A	DWS Offset (in)	N/A
N/A	Shared Landing?	N/A			
N/A	Gutter Ponding?	N/A	N/A	Gutter Slope (%)	N/A
N/A	Gutter Lip Ht (in)	N/A	N/A	Gutter X Slope (%)	N/A
N/A	Painted X Walk1?	No	N/A	Painted X Walk2?	N/A
	X Walk 1 Direction	To E		X Walk 2 Direction	N/A
N/A	X Walk 1 Width (in)	N/A	N/A	X Walk 2 Width (in)	N/A
	X Walk 1 Slope (%)	1.5		X Walk 2 Slope (%)	N/A
	X Walk 1 X Slope (%)	1.4		X Walk 2 X Slope (%)	N/A

Remove & Replace Entire Ramp.
