Access Compliance Report

Public Rights-of-Way

(Curb Ramps)

Intersection ID: 3889	Main Street: BICKHAM_LN	Cross Street: NEUHOFF_LN	Location: NW
ADA ID: 5019252DA530	Ramp Type: Perp	Initial Pass/Fail: Fail	Overall Compliance: No
Severity Score: 46.25			
Codes/Mitigation Info/Possible Solution		Field Measurements/Component Compliance

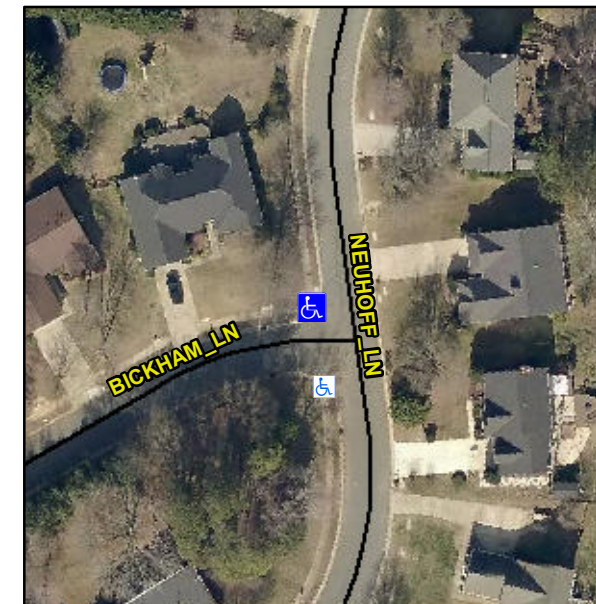
Not Found, R304.5.1, R304.2.2, R304.5.3

Compliance	Description	Data	Compliance	Description	Data
N/A	Ramp Length (in)	65.5	No	Ramp Slope (%)	8.9
No	Ramp Width (in)	40.5	No	Ramp XSlope (%)	9.1
N/A	Flare Type LT	N/A	N/A	Flare Type RT	N/A
N/A	Flare Slope LT (%)	N/A	N/A	Flare Slope RT (%)	N/A
N/A	Flare Traversable LT?	N/A	N/A	Flare Traversable RT?	N/A
N/A	Landing Length (in)	N/A	N/A	DWS Provided?	N/A
N/A	Landing Width (in)	N/A	N/A	DWS Contrast?	N/A
N/A	Landing Slope (%)	N/A	N/A	DWS Length (in)	N/A
N/A	Landing X Slope (%)	N/A	N/A	DWS Full Width?	N/A
N/A	Landing Curb? (Y/N)	N/A	N/A	DWS Offset (in)	N/A
N/A	Shared Landing?	N/A			
N/A	Gutter Ponding?	N/A	N/A	Gutter Slope (%)	N/A
N/A	Gutter Lip Ht (in)	N/A	N/A	Gutter X Slope (%)	N/A
N/A	Painted X Walk1?	No	N/A	Painted X Walk2?	N/A
	X Walk 1 Direction	To S		X Walk 2 Direction	N/A
N/A	X Walk 1 Width (in)	N/A	N/A	X Walk 2 Width (in)	N/A
	X Walk 1 Slope (%)	3.6		X Walk 2 Slope (%)	N/A
	X Walk 1 X Slope (%)	8.3		X Walk 2 X Slope (%)	N/A

N/A	Ramp inside XWalk1?	N/A	N/A	Ramp inside XWalk2?	N/A
	Road Slope (%)	N/A	N/A	Clear Space?	N/A
	Road X Slope (%)	N/A	N/A	Clear Space to XWalk (in)	N/A
N/A	Any Obstructions?	N/A	N/A	Storm Grate/Utility Hazard?	N/A
	Obstruction Type			Storm Grate/Utility Type	
		N/A			N/A
			Yes	Surface Condition? (G/P)	Good

Possible Solutions:

Remove & Replace Entire Ramp.
