Access Compliance Report

Public Rights-of-Way

(Curb Ramps)

Intersection ID: 27411	Main Street: BALLANTYNE_COMMONS_PY	Cross Street: BALLANTYNE_CORPORATE_PL	Location: NW
ADA ID: 501989972FEC	Ramp Type: Perp	Initial Pass/Fail: Fail	Overall Compliance: No
Severity Score: 12.5			
Codes/Mitigation Info/Possible Solution		Field Measurements/Component Compliance

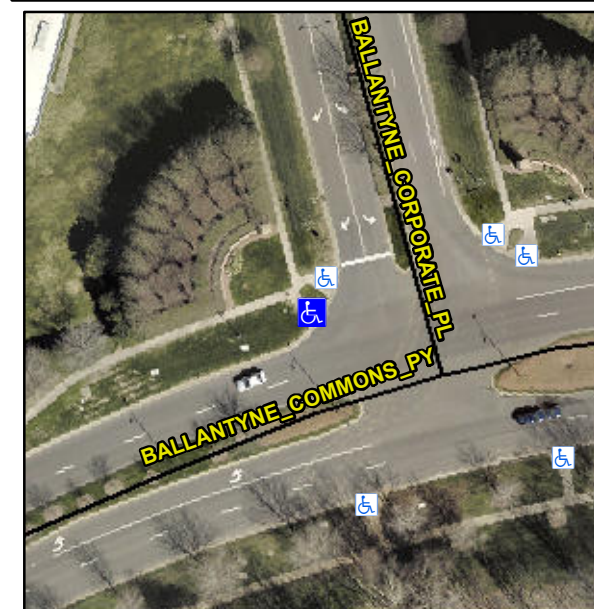
Not Found, R304.5.3

Compliance	Description	Data	Compliance	Description	Data
N/A	Ramp Length (in)	163.0	Yes	Ramp Slope (%)	7.8
Yes	Ramp Width (in)	48.0	No	Ramp XSlope (%)	6.7
N/A	Flare Type LT	N/A	N/A	Flare Type RT	N/A
N/A	Flare Slope LT (%)	N/A	N/A	Flare Slope RT (%)	N/A
N/A	Flare Traversable LT?	N/A	N/A	Flare Traversable RT?	N/A
N/A	Landing Length (in)	N/A	N/A	DWS Provided?	N/A
N/A	Landing Width (in)	N/A	N/A	DWS Contrast?	N/A
N/A	Landing Slope (%)	N/A	N/A	DWS Length (in)	N/A
N/A	Landing X Slope (%)	N/A	N/A	DWS Full Width?	N/A
N/A	Landing Curb? (Y/N)	N/A	N/A	DWS Offset (in)	N/A
N/A	Shared Landing?	N/A			
N/A	Gutter Ponding?	N/A	N/A	Gutter Slope (%)	N/A
N/A	Gutter Lip Ht (in)	N/A	N/A	Gutter X Slope (%)	N/A
N/A	Painted X Walk1?	No	N/A	Painted X Walk2?	N/A
	X Walk 1 Direction	To S		X Walk 2 Direction	N/A
N/A	X Walk 1 Width (in)	N/A	N/A	X Walk 2 Width (in)	N/A
	X Walk 1 Slope (%)	4.0		X Walk 2 Slope (%)	N/A
	X Walk 1 X Slope (%)	2.3		X Walk 2 X Slope (%)	N/A

N/A	Ramp inside XWalk1?	N/A	N/A	Ramp inside XWalk2?	N/A
	Road Slope (%)	N/A	N/A	Clear Space?	N/A
	Road X Slope (%)	N/A	N/A	Clear Space to XWalk (in)	N/A
N/A	Any Obstructions?	N/A	N/A	Storm Grate/Utility Hazard?	N/A
	Obstruction Type			Storm Grate/Utility Type	
		N/A			N/A
			Yes	Surface Condition? (G/P)	Good

Possible Solutions:

Remove & Replace Entire Ramp.
