## Access Compliance Report Public Rights-of-Way (Curb Ramps)

Intersection ID: 5967 Main Street: N\_TRYON\_ST Cross Street: MCCULLOUGH\_DR Location: SE

ADA ID: 501CB9097EC9 Ramp Type: Perp Initial Pass/Fail: Fail Overall Compliance: No Severity Score: 21.25

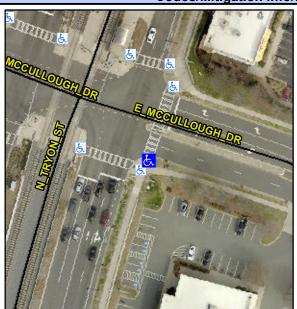
Field Measurements/Component Compliance								
Compl	iance Description	Data	Comp	liance	Description	Data		
N/A	Ramp Length (in)	96.5	Yes	Ramp	Slope (%)	6.3		
No	Ramp Width (in)	47.5	No	Ramp	XSlope (%)	6.1		
N/A	Flare Type LT	N/A	N/A	Flare	Type RT	N/A		
N/A	Flare Slope LT (%)	N/A	N/A	Flare	Slope RT (%)	N/A		
N/A	Flare Traversable LT?	N/A	N/A	Flare	Traversable RT?	N/A		
N/A	Landing Length (in)	N/A	N/A	DWS	Provided?	N/A		
N/A	Landing Width (in)	N/A	N/A	DWS	Contrast?	N/A		
N/A	Landing Slope (%)	N/A	N/A	DWS	Length (in)	N/A		
N/A	Landing X Slope (%)	N/A	N/A	DWS	Full Width?	N/A		
N/A	Landing Curb? (Y/N)	N/A	N/A	DWS	Offset (in)	N/A		
N/A	Shared Landing?	N/A						
N/A	Gutter Ponding?	N/A	N/A	Gutter	Slope (%)	N/A		
N/A	Gutter Lip Ht (in)	2.0	N/A	Gutter	X Slope (%)	N/A		
N/A	Painted X Walk1?	Yes	N/A	Painte	ed X Walk2?	N/A		
	X Walk 1 Direction	To NE		X Wal	k 2 Direction	N/A		
N/A	X Walk 1 Width (in)	120.0	N/A	X Wal	k 2 Width (in)	N/A

X Walk 1 Slope (%)	0.5		X Wal	k 2 Slope (%)	N/A		
	X Walk 1 X Slope (%)	5.8		X Wal	k 2 X Slope (%)	N/A		
N/A	Ramp inside XWalk1?	Yes	N/A	Ramp	inside XWalk2?	N/A		
	Road Slope (%)	N/A	N/A	Clear	Space?	N/A		
	Road X Slope (%)	N/A	N/A	Clear	Space to XWalk (in)	N/A		
N/A	Any Obstructions?	N/A	N/A	Storm	Grate/Utility Hazard?	N/A		
	Obstruction Type			Storm	Grate/Utility Type			
		N/A				N/A		
			Yes	Surfac	ce Condition? (G/P)	Good		
	HE RIL - 1-11

Possible Solutions:							
Remove & Replace Entire Ramp.							
·							
Surveyor Notes:							
N/A							
N/A							
PROW/ADA:							
Not Found, R304.5.1, R304.5.3

Total Cost:	\$	1850.00
