Access Compliance Report Public Rights-of-Way (Curb Ramps)

Intersection ID: 14547 Main Street: EAST_BV Cross Street: SPRINGDALE_AV Location: SW

ADA ID: 5027995E6500 Ramp Type: Directional1 Initial Pass/Fail: Fail Overall Compliance: No Severity Score: 12.5

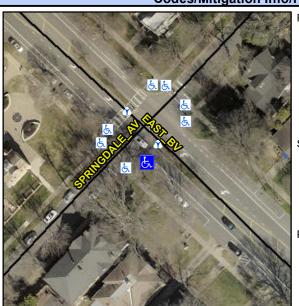
Field Measurements/Component Compliance							
Comp	liance Description	Data	Comp	liance Description	Data		
N/A	Ramp Length (in)	60.0	N/A	Grade Break?	N/A		
Yes	Ramp Width (in)	72.0	N/A	Grade Break Slope (%)	0.0		
No	Ramp Slope (%)	8.8	N/A	Grade Break XSlope (%)	0.0		
Yes	Ramp XSlope (%)	0.6					
N/A	Flare Type LT	N/A	N/A	Flare Type RT	N/A		
N/A	Flare Slope LT (%)	N/A	N/A	Flare Slope RT (%)	0.0		
N/A	Flare Traversable LT?	N/A	N/A	Flare Traversable RT?	N/A		
N/A	Landing Length (in)	0.0	N/A	DWS Provided?	N/A		
N/A	Landing Width (in)	0.0	N/A	DWS Contrast?	N/A		
N/A	Landing Slope (%)	0.0	N/A	DWS Length (in)	N/A		
N/A	Landing X Slope (%)	0.0	N/A	DWS Full Width?	N/A		
N/A	Landing Curb? (Y/N)	N/A	N/A	DWS Offset LT (in)	N/A		
N/A	Shared Landing?	N/A	N/A	DWS Offset RT (in)	N/A		
N/A	Gutter Ponding?	0.0	N/A	Gutter Slope (%)	N/A		
N/A	Gutter Lip Ht (in)	0.0	N/A	Gutter X Slope (%)	N/A		
N/A	Painted X Walk1?	No		Road Slope (%)	5.1

ossible Solution		
Possible Solutions:	Complian	
Remove & Replace Entire Ramp.	N/A	Rar
·	Yes	Rar
	No	Ran
	Yes	Ran
	N/A	Flai
	N/A	Flai
surveyor Notes:	N/A	Flar
N/A	N/A	Lan
	N/A	Lan
	N/A	Lan
	N/A	Lan
ROW/ADA:	N/A	Lan
R304.2.2	N/A	Sha
	N/A	Gut
	N/A	Gut
	N/A	Pair
		ΧW
