# Access Compliance Report

## Public Rights-of-Way

### (Curb Ramps)

Intersection ID: 47573	Main Street: SEDGEBURN_DR	Cross Street: GAILES_DR	Location: SE
ADA ID: 5037B340D3BC	Ramp Type: PerpDiag	Initial Pass/Fail: Fail	Overall Compliance: No
Severity Score: 8.75			
Codes/Mitigation Info/Possible Solution		Field Measurements/Component Compliance

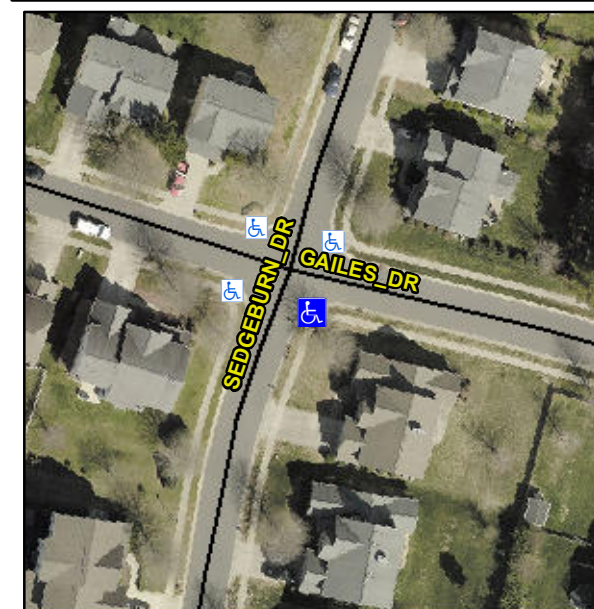
**Not Found, R304.5.1**

Compliance	Description	Data	Compliance	Description	Data
N/A	Ramp Length (in)	48.0	Yes	Ramp Slope (%)	8.2
No	Ramp Width (in)	42.5	Yes	Ramp XSlope (%)	1.1
N/A	Flare Type LT	N/A	N/A	Flare Type RT	N/A
N/A	Flare Slope LT (%)	N/A	N/A	Flare Slope RT (%)	N/A
N/A	Flare Traversable LT?	N/A	N/A	Flare Traversable RT?	N/A
N/A	Landing Length (in)	N/A	N/A	DWS Provided?	N/A
N/A	Landing Width (in)	N/A	N/A	DWS Contrast?	N/A
N/A	Landing Slope (%)	N/A	N/A	DWS Length (in)	N/A
N/A	Landing X Slope (%)	N/A	N/A	DWS Full Width?	N/A
N/A	Landing Curb? (Y/N)	N/A	N/A	DWS Offset (in)	N/A
N/A	Shared Landing?	N/A			
N/A	Gutter Ponding?	N/A	N/A	Gutter Slope (%)	N/A
N/A	Gutter Lip Ht (in)	N/A	N/A	Gutter X Slope (%)	N/A
N/A	Painted X Walk1?	No	N/A	Painted X Walk2?	No
	X Walk 1 Direction	To NE		X Walk 2 Direction	To NW
N/A	X Walk 1 Width (in)	N/A	N/A	X Walk 2 Width (in)	N/A
	X Walk 1 Slope (%)	0.4		X Walk 2 Slope (%)	0.6
	X Walk 1 X Slope (%)	1.3		X Walk 2 X Slope (%)	1.8

N/A	Ramp inside XWalk1?	N/A	N/A	Ramp inside XWalk2?	N/A
	Road Slope (%)	1.2	N/A	Clear Space?	N/A
	Road X Slope (%)	2.2	N/A	Clear Space to XWalk (in)	N/A
N/A	Any Obstructions?	N/A	N/A	Storm Grate/Utility Hazard?	N/A
	Obstruction Type			Storm Grate/Utility Type	
		N/A			N/A
			Yes	Surface Condition? (G/P)	Good

**Remove & Replace Curb Ramp With Two New Directional Ramps or Equivalent.**

Total Cost: \$ 3200.00
