# Access Compliance Report

## Public Rights-of-Way

### (Curb Ramps)

Intersection ID: N/A	Main Street: PHILLIPS_AV	Cross Street: BARRINGER_DR	Location: SE
ADA ID: 504A5C481C47	Ramp Type: Perp	Initial Pass/Fail: Fail	Overall Compliance: No
			Severity Score: 13.75

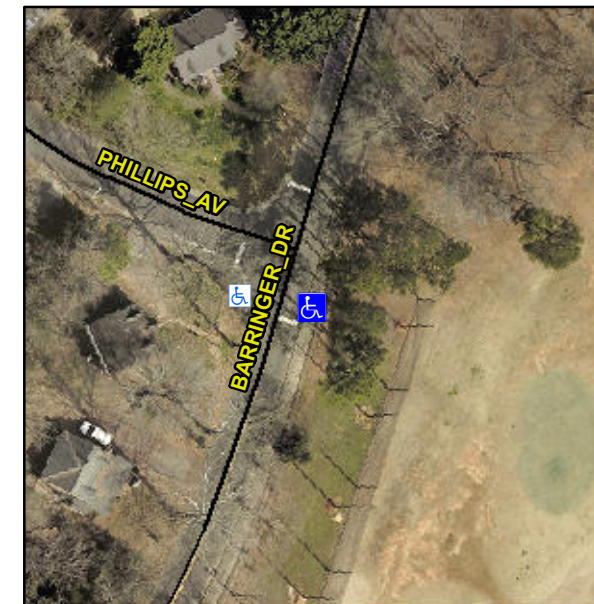
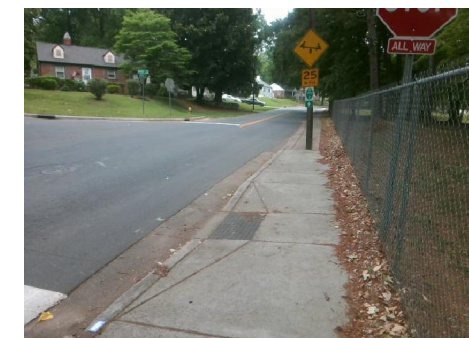
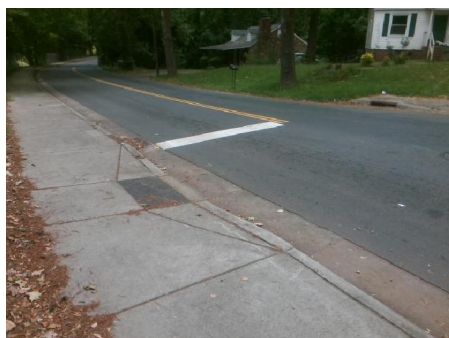
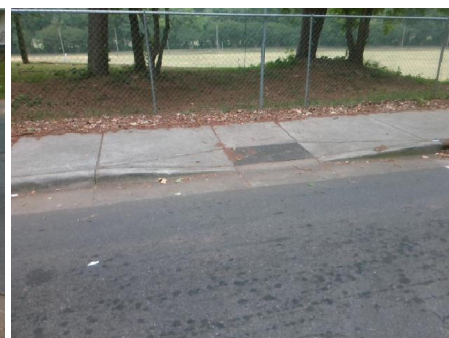
**Not Found, R304.2.2, R304.5.3**

Compliance	Description	Data	Compliance	Description	Data
N/A	Ramp Length (in)	72.0	No	Ramp Slope (%)	8.5
Yes	Ramp Width (in)	48.0	No	Ramp XSlope (%)	2.8
N/A	Flare Type LT	N/A	N/A	Flare Type RT	N/A
N/A	Flare Slope LT (%)	N/A	N/A	Flare Slope RT (%)	N/A
N/A	Flare Traversable LT?	N/A	N/A	Flare Traversable RT?	N/A
N/A	Landing Length (in)	N/A	N/A	DWS Provided?	N/A
N/A	Landing Width (in)	N/A	N/A	DWS Contrast?	N/A
N/A	Landing Slope (%)	N/A	N/A	DWS Length (in)	N/A
N/A	Landing X Slope (%)	N/A	N/A	DWS Full Width?	N/A
N/A	Landing Curb? (Y/N)	N/A	N/A	DWS Offset (in)	N/A
N/A	Shared Landing?	N/A			
N/A	Gutter Ponding?	N/A	N/A	Gutter Slope (%)	N/A
N/A	Gutter Lip Ht (in)	N/A	N/A	Gutter X Slope (%)	N/A
N/A	Painted X Walk1?	No	N/A	Painted X Walk2?	N/A
	X Walk 1 Direction	To NW		X Walk 2 Direction	N/A
N/A	X Walk 1 Width (in)	N/A	N/A	X Walk 2 Width (in)	N/A
	X Walk 1 Slope (%)	5.1		X Walk 2 Slope (%)	N/A
	X Walk 1 X Slope (%)	3.8		X Walk 2 X Slope (%)	N/A

N/A	Ramp inside XWalk1?	N/A	N/A	Ramp inside XWalk2?	N/A
	Road Slope (%)	N/A	N/A	Clear Space?	N/A
	Road X Slope (%)	N/A	N/A	Clear Space to XWalk (in)	N/A
N/A	Any Obstructions?	N/A	N/A	Storm Grate/Utility Hazard?	N/A
	Obstruction Type			Storm Grate/Utility Type	
		N/A			N/A
			Yes	Surface Condition? (G/P)	Good

**Remove & Replace Entire Ramp.**

Total Cost: \$ 1850.00
