Access Compliance Report

Public Rights-of-Way

(Curb Ramps)

Intersection ID: 13705	Main Street: CENTRAL_AV	Cross Street: CYRUS_DR	Location: SW
ADA ID: 504D533A57F1	Ramp Type: Perp	Initial Pass/Fail: Fail	Overall Compliance: No
		Severity Score: 10

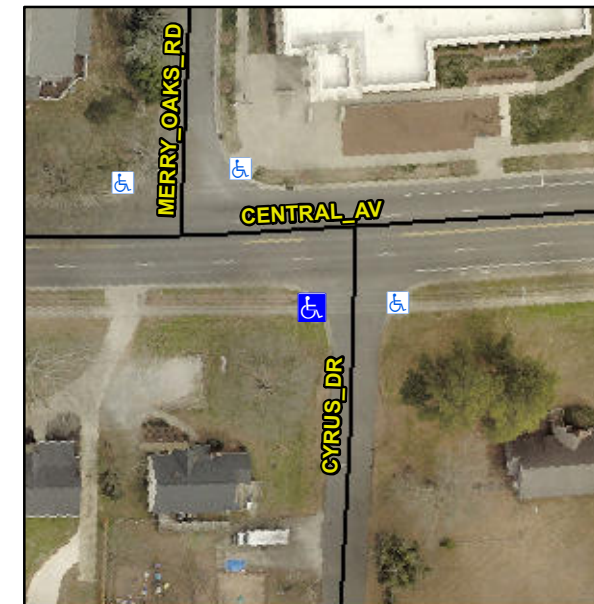
Not Found, R304.5.1, R304.5.3

Compliance	Description	Data	Compliance	Description	Data
N/A	Ramp Length (in)	96.0	Yes	Ramp Slope (%)	5.3
No	Ramp Width (in)	37.0	No	Ramp XSlope (%)	3.0
N/A	Flare Type LT	N/A	N/A	Flare Type RT	N/A
N/A	Flare Slope LT (%)	N/A	N/A	Flare Slope RT (%)	N/A
N/A	Flare Traversable LT?	N/A	N/A	Flare Traversable RT?	N/A
N/A	Landing Length (in)	N/A	N/A	DWS Provided?	N/A
N/A	Landing Width (in)	N/A	N/A	DWS Contrast?	N/A
N/A	Landing Slope (%)	N/A	N/A	DWS Length (in)	N/A
N/A	Landing X Slope (%)	N/A	N/A	DWS Full Width?	N/A
N/A	Landing Curb? (Y/N)	N/A	N/A	DWS Offset (in)	N/A
N/A	Shared Landing?	N/A			
N/A	Gutter Ponding?	N/A	N/A	Gutter Slope (%)	N/A
N/A	Gutter Lip Ht (in)	N/A	N/A	Gutter X Slope (%)	N/A
N/A	Painted X Walk1?	No	N/A	Painted X Walk2?	N/A
	X Walk 1 Direction	To E		X Walk 2 Direction	N/A
N/A	X Walk 1 Width (in)	N/A	N/A	X Walk 2 Width (in)	N/A
	X Walk 1 Slope (%)	6.6		X Walk 2 Slope (%)	N/A
	X Walk 1 X Slope (%)	4.2		X Walk 2 X Slope (%)	N/A

Remove & Replace Entire Ramp.
