# Access Compliance Report

## Public Rights-of-Way

### (Curb Ramps)

Intersection ID: 3928	Main Street: BICKHAM_LN	Cross Street: KIRKGARD_TL	Location:	N
ADA ID: 506A5A826EB3	Ramp Type: Perp	Initial Pass/Fail: Fail	Overall Compliance: No	Severity Score: 22.5
Codes/Mitigation Info/Possible Solution		Field Measurements/Component Compliance

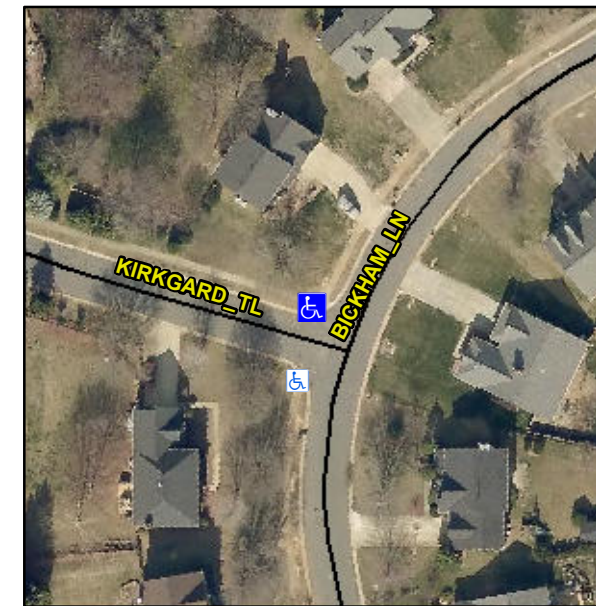
**Not Found, R304.5.1, R304.2.2, R304.5.3**

Compliance	Description	Data	Compliance	Description	Data
N/A	Ramp Length (in)	30.5	No	Ramp Slope (%)	9.0
No	Ramp Width (in)	40.0	No	Ramp XSlope (%)	2.4
N/A	Flare Type LT	N/A	N/A	Flare Type RT	N/A
N/A	Flare Slope LT (%)	N/A	N/A	Flare Slope RT (%)	N/A
N/A	Flare Traversable LT?	N/A	N/A	Flare Traversable RT?	N/A
N/A	Landing Length (in)	N/A	N/A	DWS Provided?	N/A
N/A	Landing Width (in)	N/A	N/A	DWS Contrast?	N/A
N/A	Landing Slope (%)	N/A	N/A	DWS Length (in)	N/A
N/A	Landing X Slope (%)	N/A	N/A	DWS Full Width?	N/A
N/A	Landing Curb? (Y/N)	N/A	N/A	DWS Offset (in)	N/A
N/A	Shared Landing?	N/A			
N/A	Gutter Ponding?	N/A	N/A	Gutter Slope (%)	N/A
N/A	Gutter Lip Ht (in)	N/A	N/A	Gutter X Slope (%)	N/A
N/A	Painted X Walk1?	No	N/A	Painted X Walk2?	N/A
	X Walk 1 Direction	To SW		X Walk 2 Direction	N/A
N/A	X Walk 1 Width (in)	N/A	N/A	X Walk 2 Width (in)	N/A
	X Walk 1 Slope (%)	3.9		X Walk 2 Slope (%)	N/A
	X Walk 1 X Slope (%)	0.6		X Walk 2 X Slope (%)	N/A

N/A	Ramp inside XWalk1?	N/A	N/A	Ramp inside XWalk2?	N/A
	Road Slope (%)	N/A	N/A	Clear Space?	N/A
	Road X Slope (%)	N/A	N/A	Clear Space to XWalk (in)	N/A
N/A	Any Obstructions?	N/A	N/A	Storm Grate/Utility Hazard?	N/A
	Obstruction Type			Storm Grate/Utility Type	
		N/A			N/A
			Yes	Surface Condition? (G/P)	Good

Possible Solutions:

**Remove & Replace Entire Ramp.**

Total Cost: \$ 1850.00
