Access Compliance Report

Public Rights-of-Way

(Curb Ramps)

Intersection ID: 15397	Main Street: N_WENDOVER_RD	Cross Street: N_WENDOVER_RD_RA	Location: E
ADA ID: 5092D75A1622	Ramp Type: Perp	Initial Pass/Fail: Fail	Overall Compliance: No
		Severity Score: 10

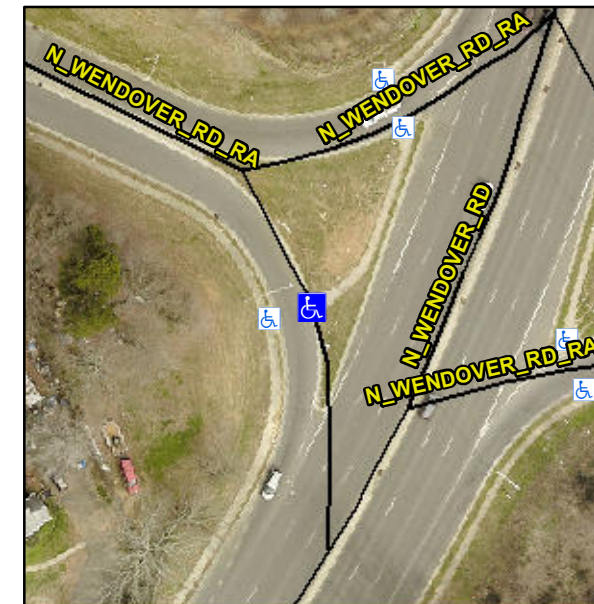
Not Found, R304.5.1

Compliance	Description	Data	Compliance	Description	Data
N/A	Ramp Length (in)	79.0	Yes	Ramp Slope (%)	8.1
No	Ramp Width (in)	46.0	Yes	Ramp XSlope (%)	3.5
N/A	Flare Type LT	N/A	N/A	Flare Type RT	N/A
N/A	Flare Slope LT (%)	N/A	N/A	Flare Slope RT (%)	N/A
N/A	Flare Traversable LT?	N/A	N/A	Flare Traversable RT?	N/A
N/A	Landing Length (in)	N/A	N/A	DWS Provided?	N/A
N/A	Landing Width (in)	N/A	N/A	DWS Contrast?	N/A
N/A	Landing Slope (%)	N/A	N/A	DWS Length (in)	N/A
N/A	Landing X Slope (%)	N/A	N/A	DWS Full Width?	N/A
N/A	Landing Curb? (Y/N)	N/A	N/A	DWS Offset (in)	N/A
N/A	Shared Landing?	N/A			
N/A	Gutter Ponding?	N/A	N/A	Gutter Slope (%)	N/A
N/A	Gutter Lip Ht (in)	N/A	N/A	Gutter X Slope (%)	N/A
N/A	Painted X Walk1?	No	N/A	Painted X Walk2?	N/A
	X Walk 1 Direction	To W		X Walk 2 Direction	N/A
N/A	X Walk 1 Width (in)	N/A	N/A	X Walk 2 Width (in)	N/A
	X Walk 1 Slope (%)	5.5		X Walk 2 Slope (%)	N/A
	X Walk 1 X Slope (%)	4.3		X Walk 2 X Slope (%)	N/A

N/A	Ramp inside XWalk1?	N/A	N/A	Ramp inside XWalk2?	N/A
	Road Slope (%)	N/A	N/A	Clear Space?	N/A
	Road X Slope (%)	N/A	N/A	Clear Space to XWalk (in)	N/A
N/A	Any Obstructions?	N/A	N/A	Storm Grate/Utility Hazard?	N/A
	Obstruction Type			Storm Grate/Utility Type	
		N/A			N/A
			Yes	Surface Condition? (G/P)	Good

Remove & Replace Entire Ramp.
