Access Compliance Report

Public Rights-of-Way

(Curb Ramps)

Intersection ID: 47818	Main Street: ROYAL_FERN_LN	Cross Street: ROCKMOOR_RIDGE_RD	Location: NW
ADA ID: 509BCBE1085A	Ramp Type: PerpDiag	Initial Pass/Fail: Fail	Overall Compliance: No
Severity Score: 21.25			
Codes/Mitigation Info/Possible Solution		Field Measurements/Component Compliance

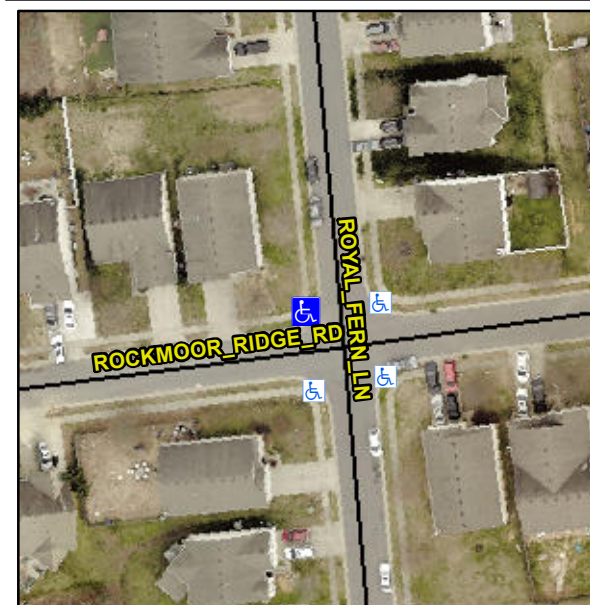
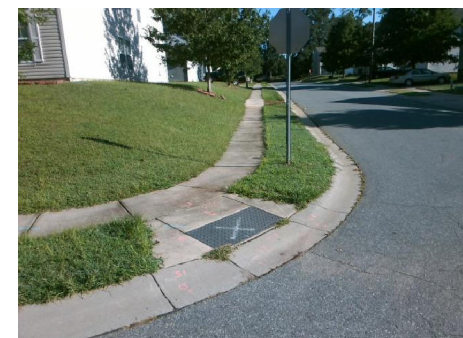
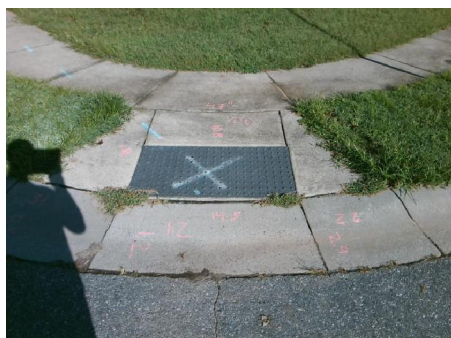
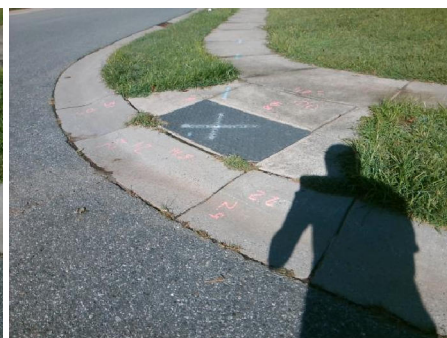
Not Found, R304.5.1, R304.2.2

Compliance	Description	Data	Compliance	Description	Data
N/A	Ramp Length (in)	48.0	No	Ramp Slope (%)	10.8
No	Ramp Width (in)	47.0	Yes	Ramp XSlope (%)	0.0
N/A	Flare Type LT	N/A	N/A	Flare Type RT	N/A
N/A	Flare Slope LT (%)	N/A	N/A	Flare Slope RT (%)	N/A
N/A	Flare Traversable LT?	N/A	N/A	Flare Traversable RT?	N/A
N/A	Landing Length (in)	N/A	N/A	DWS Provided?	N/A
N/A	Landing Width (in)	N/A	N/A	DWS Contrast?	N/A
N/A	Landing Slope (%)	N/A	N/A	DWS Length (in)	N/A
N/A	Landing X Slope (%)	N/A	N/A	DWS Full Width?	N/A
N/A	Landing Curb? (Y/N)	N/A	N/A	DWS Offset (in)	N/A
N/A	Shared Landing?	N/A			
N/A	Gutter Ponding?	N/A	N/A	Gutter Slope (%)	N/A
N/A	Gutter Lip Ht (in)	N/A	N/A	Gutter X Slope (%)	N/A
N/A	Painted X Walk1?	No	N/A	Painted X Walk2?	No
	X Walk 1 Direction	To S		X Walk 2 Direction	To E
N/A	X Walk 1 Width (in)	N/A	N/A	X Walk 2 Width (in)	N/A
	X Walk 1 Slope (%)	0.5		X Walk 2 Slope (%)	2.9
	X Walk 1 X Slope (%)	3.1		X Walk 2 X Slope (%)	2.2

N/A	Ramp inside XWalk1?	N/A	N/A	Ramp inside XWalk2?	N/A
	Road Slope (%)	1.2	N/A	Clear Space?	N/A
	Road X Slope (%)	1.2	N/A	Clear Space to XWalk (in)	N/A
N/A	Any Obstructions?	N/A	N/A	Storm Grate/Utility Hazard?	N/A
	Obstruction Type			Storm Grate/Utility Type	
		N/A			N/A
		Yes		Surface Condition? (G/P)	Good

Remove & Replace Curb Ramp With Two New Directional Ramps or Equivalent.
