Access Compliance Report

Public Rights-of-Way

(Curb Ramps)

| Intersection ID: 29760 | Main Street: CREEK_POINTE_DR | Cross Street: FAWN_HILL_RD | Location: SW |

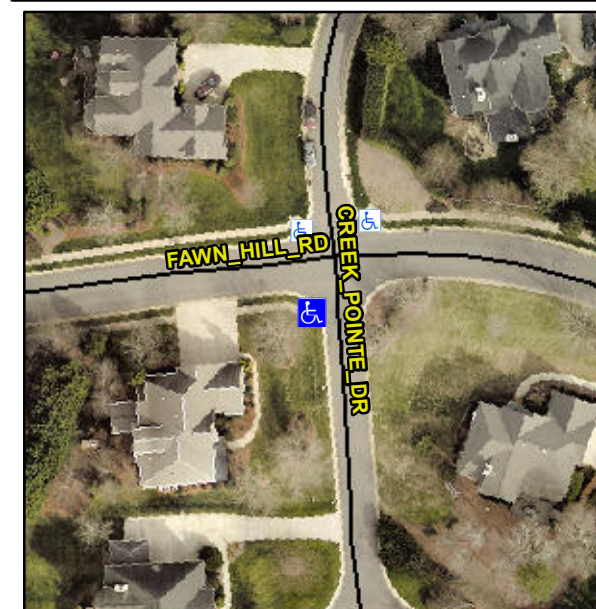
| Severity Score: 8.75 | | | |

Not Found, R304.5.1

| Compliance | Description | Data | Compliance | Description | Data |
|---|---|---|---|---|---|
| No | Ramp Width (in) | 47.0 | Yes | Ramp XSlope (%) | 2.0 |

Remove & Replace Entire Ramp.
