Access Compliance Report

Public Rights-of-Way

(Curb Ramps)

Intersection ID: 31970	Main Street: BERNBROOKE CT	Cross Street: THORNTON OAKS CT	Location: SW
ADA ID: 50B572CB3B50	Ramp Type: PerpDiag	Initial Pass/Fail: Fail	Overall Compliance: No
Codes/Mitigation Info/Possible Solution			Severity Score: 10
			Field Measurements/Component Compliance

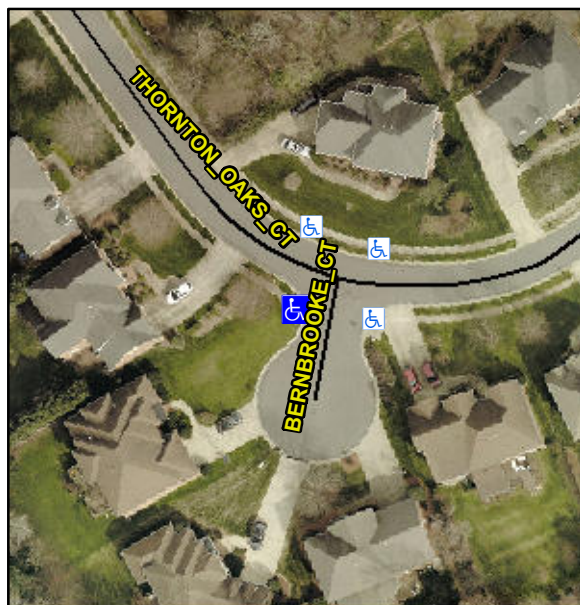
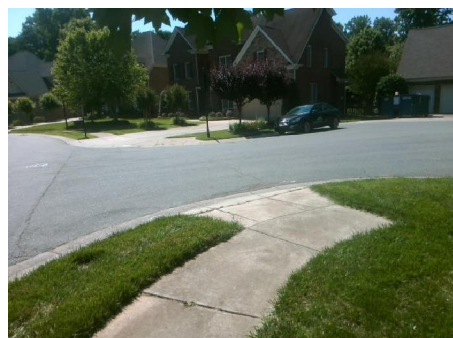
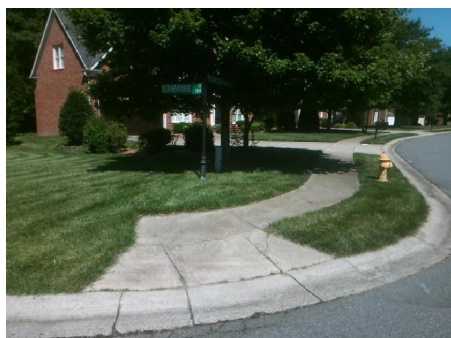
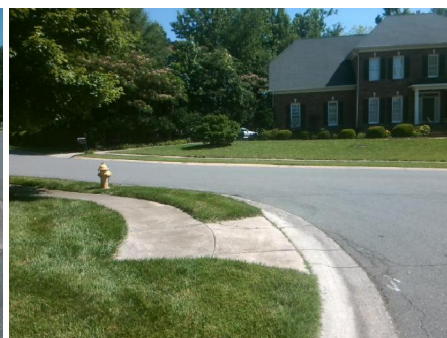
Not Found, R304.5.1, R304.5.3

Compliance	Description	Data	Compliance	Description	Data
N/A	Ramp Length (in)	43.0	Yes	Ramp Slope (%)	6.2
No	Ramp Width (in)	41.0	No	Ramp XSlope (%)	3.9
N/A	Flare Type LT	N/A	N/A	Flare Type RT	N/A
N/A	Flare Slope LT (%)	N/A	N/A	Flare Slope RT (%)	N/A
N/A	Flare Traversable LT?	N/A	N/A	Flare Traversable RT?	N/A
N/A	Landing Length (in)	N/A	N/A	DWS Provided?	N/A
N/A	Landing Width (in)	N/A	N/A	DWS Contrast?	N/A
N/A	Landing Slope (%)	N/A	N/A	DWS Length (in)	N/A
N/A	Landing X Slope (%)	N/A	N/A	DWS Full Width?	N/A
N/A	Landing Curb? (Y/N)	N/A	N/A	DWS Offset (in)	N/A
N/A	Shared Landing?	N/A			
N/A	Gutter Ponding?	N/A	N/A	Gutter Slope (%)	N/A
N/A	Gutter Lip Ht (in)	N/A	N/A	Gutter X Slope (%)	N/A
N/A	Painted X Walk1?	No	N/A	Painted X Walk2?	No
	X Walk 1 Direction	To E		X Walk 2 Direction	To N
N/A	X Walk 1 Width (in)	N/A	N/A	X Walk 2 Width (in)	N/A
	X Walk 1 Slope (%)	1.7		X Walk 2 Slope (%)	2.4
	X Walk 1 X Slope (%)	1.4		X Walk 2 X Slope (%)	0.3

N/A	Ramp inside XWalk1?	N/A	N/A	Ramp inside XWalk2?	N/A
	Road Slope (%)	2.2	N/A	Clear Space?	N/A
	Road X Slope (%)	2.4	N/A	Clear Space to XWalk (in)	N/A
N/A	Any Obstructions?	N/A	N/A	Storm Grate/Utility Hazard?	N/A
	Obstruction Type			Storm Grate/Utility Type	
		N/A			N/A
			Yes	Surface Condition? (G/P)	Good

Remove & Replace Curb Ramp With Two New Directional Ramps or Equivalent.
