Access Compliance Report

Public Rights-of-Way

(Curb Ramps)

Intersection ID: 20834		Main Street: COLONY_CROSSING_DR		Cross Street: COLONY_RD		Location: NE					
ADA ID: 50C5357A5DEF		Ramp Type: Directional1		Initial Pass/Fail: Fail		Overall Compliance: No		Severity Score: 26.25			
Codes/Mitigation Info/Possible Solution				Field Measurements/Component Compliance

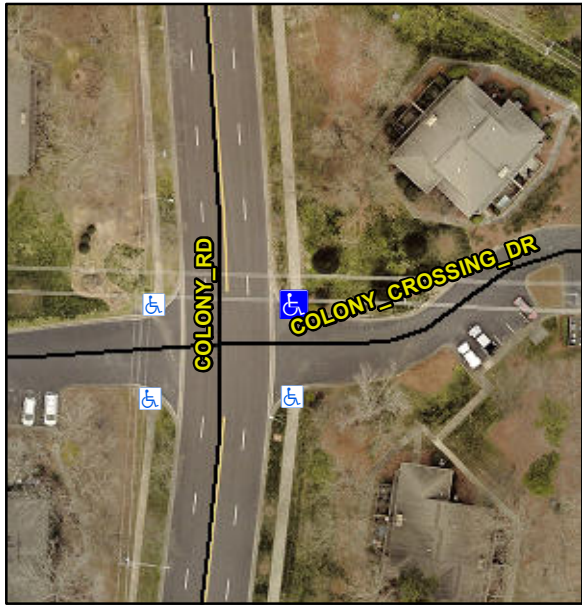
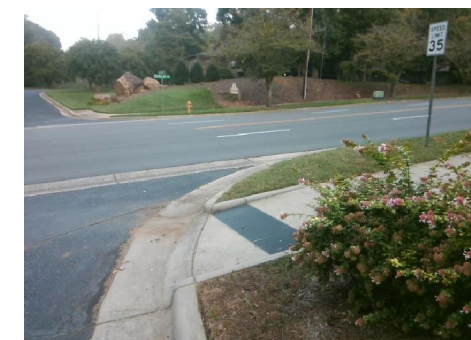
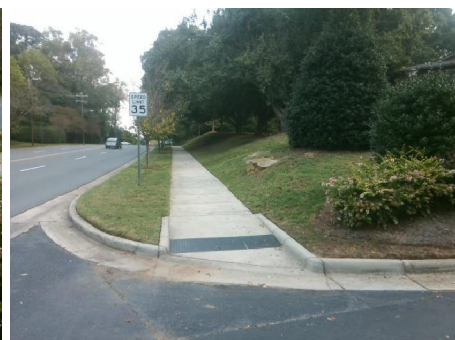
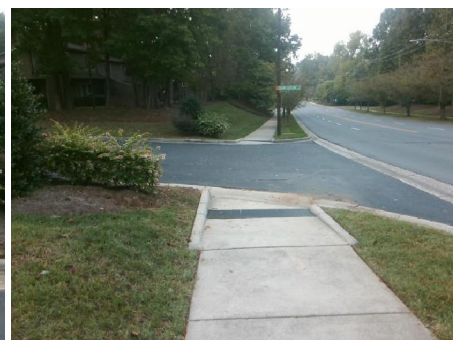
<div>Street 1 NameCOLONY CROSSING DR</div> <div>Stop Condition-Street 1None</div> <div>Street 2 NameN/A</div> <div>Stop Condition-Street 2N/A</div>				Possible Solutions:		Compliance		Description		Data	
				Remove & Replace Entire Ramp.		N/A	Ramp Length (in)	80.0	N/A	Grade Break?	N/A
						Yes	Ramp Width (in)	72.0	N/A	Grade Break Slope (%)	0.0
						No	Ramp Slope (%)	12.7	N/A	Grade Break XSlope (%)	0.0
						Yes	Ramp XSlope (%)	3.4			
						N/A	Flare Type LT	N/A	N/A	Flare Type RT	N/A
						N/A	Flare Slope LT (%)	N/A	N/A	Flare Slope RT (%)	0.0
						N/A	Flare Traversable LT?	N/A	N/A	Flare Traversable RT?	N/A

N/A	Landing Length (in)	0.0	N/A	DWS Provided?	N/A
						N/A	Landing Width (in)	0.0	N/A	DWS Contrast?	N/A
		N/A	Landing Slope (%)	0.0	N/A	DWS Length (in)	N/A				
		N/A	Landing X Slope (%)	0.0	N/A	DWS Full Width?	N/A				
		N/A	Landing Curb? (Y/N)	N/A	N/A	DWS Offset LT (in)	N/A				
		N/A	Shared Landing?	N/A	N/A	DWS Offset RT (in)	N/A				
		N/A	Gutter Ponding?	0.0	N/A	Gutter Slope (%)	N/A				
		N/A	Gutter Lip Ht (in)	0.0	N/A	Gutter X Slope (%)	N/A				
		N/A	Painted X Walk1?	No		Road Slope (%)	3.3				
			X Walk 1 Direction	To SW		Road X Slope (%)	3.8				
			X Walk 1 Width (in)	N/A		Clear Space?	N/A				
			X Walk 1 Slope (%)	3.3	N/A	Clear Space to XWalk (in)	N/A				
			X Walk 1 X Slope (%)	3.8	N/A	Storm Grate/Utility Hazard?	N/A				
		N/A	Ramp inside XWalk1?	N/A		Storm Grate/Utility Type					
		N/A	Any Obstructions?	N/A			N/A				
			Obstruction Type		Yes	Surface Condition? (G/P)	Good				
					N/A	Curb Slope (%)	8.8

Total Cost:	\$	1600.00
