Access Compliance Report

Public Rights-of-Way

(Curb Ramps)

Intersection ID: 10675	Main Street: HERRIN_AV	Cross Street: THE_PLAZA	Location: W
ADA ID: 50C643F5F660	Ramp Type: Perp	Initial Pass/Fail: Fail	Overall Compliance: No
Severity Score: 22.5			
Codes/Mitigation Info/Possible Solution		Field Measurements/Component Compliance

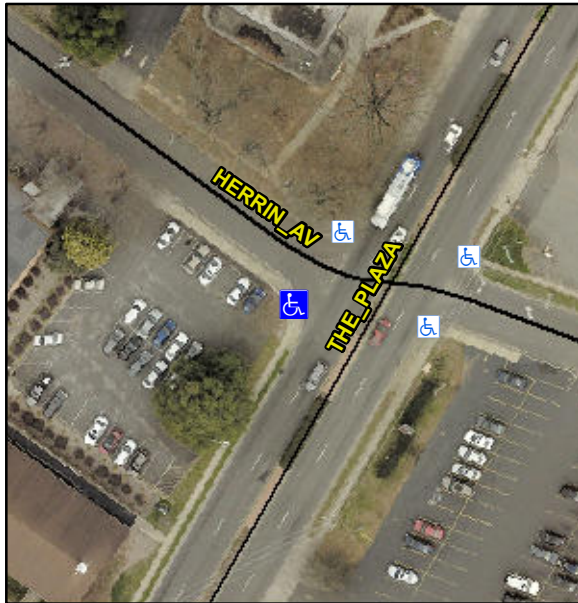
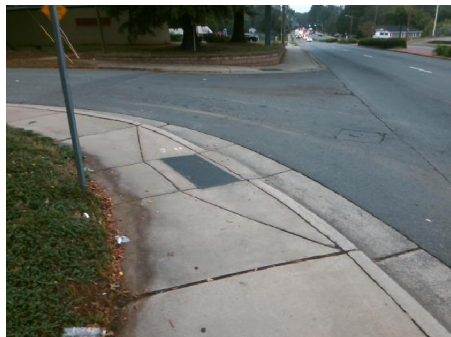
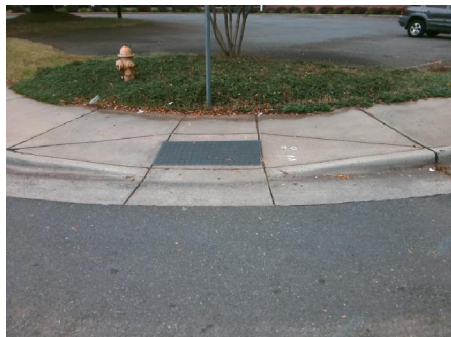
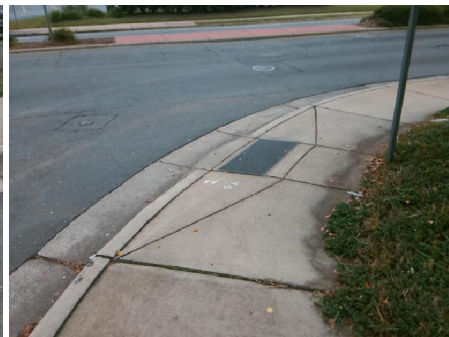
PROW/ADA:

Not Found, R304.5.1, R304.2.2, R304.5.3

Compliance	Description	Data	Compliance	Description	Data
N/A	Ramp Length (in)	35.5	No	Ramp Slope (%)	8.8
No	Ramp Width (in)	45.0	No	Ramp XSlope (%)	4.0
N/A	Flare Type LT	N/A	N/A	Flare Type RT	N/A
N/A	Flare Slope LT (%)	N/A	N/A	Flare Slope RT (%)	N/A
N/A	Flare Traversable LT?	N/A	N/A	Flare Traversable RT?	N/A
N/A	Landing Length (in)	N/A	N/A	DWS Provided?	N/A
N/A	Landing Width (in)	N/A	N/A	DWS Contrast?	N/A
N/A	Landing Slope (%)	N/A	N/A	DWS Length (in)	N/A
N/A	Landing X Slope (%)	N/A	N/A	DWS Full Width?	N/A
N/A	Landing Curb? (Y/N)	N/A	N/A	DWS Offset (in)	N/A
N/A	Shared Landing?	N/A			
N/A	Gutter Ponding?	N/A	N/A	Gutter Slope (%)	N/A
N/A	Gutter Lip Ht (in)	N/A	N/A	Gutter X Slope (%)	N/A
N/A	Painted X Walk1?	No	N/A	Painted X Walk2?	N/A
	X Walk 1 Direction	To NE		X Walk 2 Direction	N/A
N/A	X Walk 1 Width (in)	N/A	N/A	X Walk 2 Width (in)	N/A
	X Walk 1 Slope (%)	0.9		X Walk 2 Slope (%)	N/A
	X Walk 1 X Slope (%)	4.3		X Walk 2 X Slope (%)	N/A

N/A	Ramp inside XWalk1?	N/A	N/A	Ramp inside XWalk2?	N/A
	Road Slope (%)	N/A	N/A	Clear Space?	N/A
	Road X Slope (%)	N/A	N/A	Clear Space to XWalk (in)	N/A
N/A	Any Obstructions?	N/A	N/A	Storm Grate/Utility Hazard?	N/A
	Obstruction Type			Storm Grate/Utility Type	
		N/A			N/A
			Yes	Surface Condition? (G/P)	Good

Possible Solutions:

Remove & Replace Entire Ramp.
