Access Compliance Report

Public Rights-of-Way

(Curb Ramps)

Intersection ID: 51046	Main Street: LONGNOR_ST	Cross Street: PALATINE_LN	Location: SE
ADA ID: 50C91891F2BE	Ramp Type: PerpDiag	Initial Pass/Fail: Pass	Overall Compliance: No
		Severity Score: 5.25

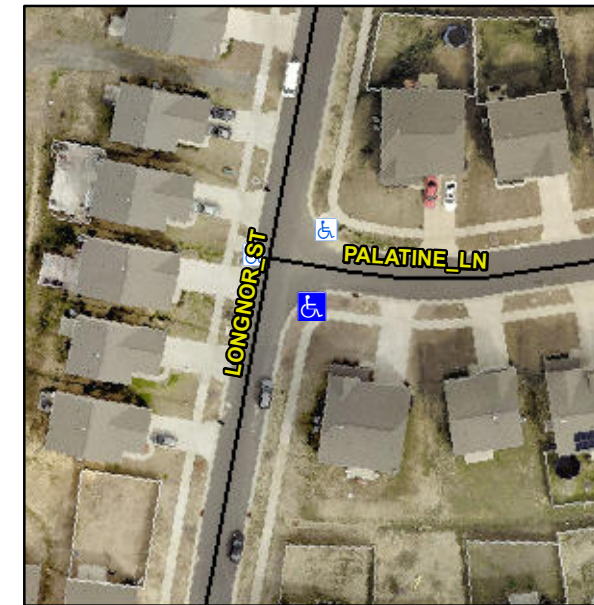
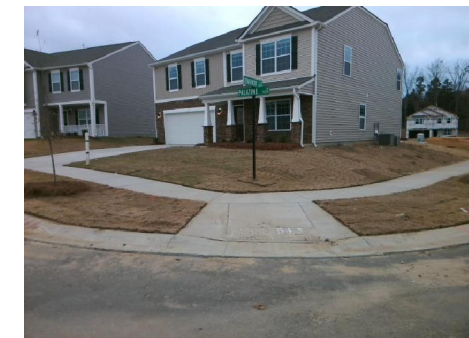
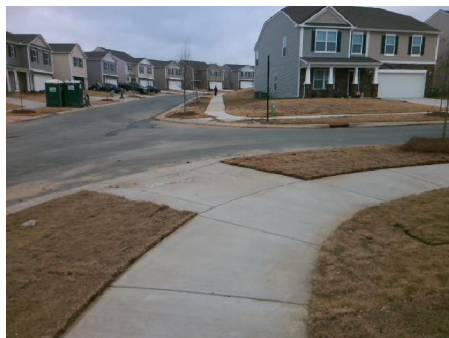
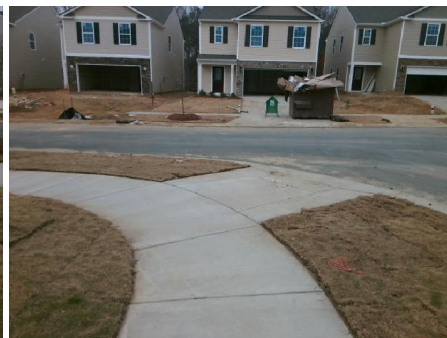
Compliance	Description	Data	Compliance	Description	Data
N/A	Ramp Length (in)	96.0	Yes	Ramp Slope (%)	7.0
Yes	Ramp Width (in)	60.5	No	Ramp XSlope (%)	3.6
N/A	Flare Type LT	Sloped	N/A	Flare Type RT	N/A
N/A	Flare Slope LT (%)	12.5	Yes	Flare Slope RT (%)	7.5
N/A	Flare Traversable LT?	Yes	N/A	Flare Traversable RT?	Yes
Yes	Landing Length (in)	59.5	Yes	DWS Provided?	Yes
Yes	Landing Width (in)	60.0	Yes	DWS Contrast?	Yes
Yes	Landing Slope (%)	1.4	Yes	DWS Length (in)	24.0
Yes	Landing X Slope (%)	1.1	Yes	DWS Full Width?	Yes
N/A	Landing Curb? (Y/N)	No	No	DWS Offset (in)	5.0
N/A	Shared Landing?	No			
Yes	Gutter Ponding?	No	Yes	Gutter Slope (%)	5.0
Yes	Gutter Lip Ht (in)	0.0	No	Gutter X Slope (%)	4.0
N/A	Painted X Walk1?	No	N/A	Painted X Walk2?	No
	X Walk 1 Direction	To N		X Walk 2 Direction	To W
N/A	X Walk 1 Width (in)	N/A	N/A	X Walk 2 Width (in)	N/A
	X Walk 1 Slope (%)	2.8		X Walk 2 Slope (%)	0.2
	X Walk 1 X Slope (%)	1.3		X Walk 2 X Slope (%)	4.2

N/A	Ramp inside XWalk1?	N/A	N/A	Ramp inside XWalk2?	N/A
	Road Slope (%)	2.3	N/A	Clear Space?	Yes
	Road X Slope (%)	2.7	N/A	Clear Space to XWalk (in)	N/A
Yes	Any Obstructions?	No	Yes	Storm Grate/Utility Hazard?	No
	Obstruction Type			Storm Grate/Utility Type	
		N/A			N/A
			Yes	Surface Condition? (G/P)	Good

Remove & Replace Curb Ramp With Two New Directional Ramps or Equivalent. Remove & Replace Gutter.
