Access Compliance Report

Public Rights-of-Way

(Curb Ramps)

Intersection ID: N/A	Main Street: SOUTHGROVE_ST	Cross Street: WAVERLY_WALK_AV	Location: NW
ADA ID: 50DEDF463DE1	Ramp Type: Perp	Initial Pass/Fail: Fail	Overall Compliance: No
Severity Score: 25			
Codes/Mitigation Info/Possible Solution		Field Measurements/Component Compliance

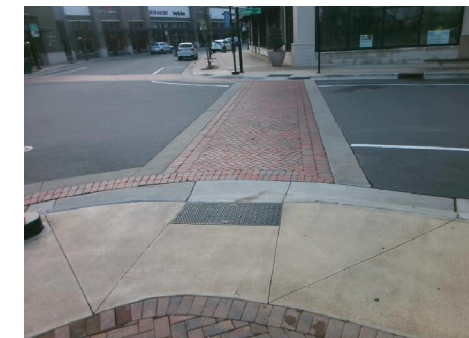
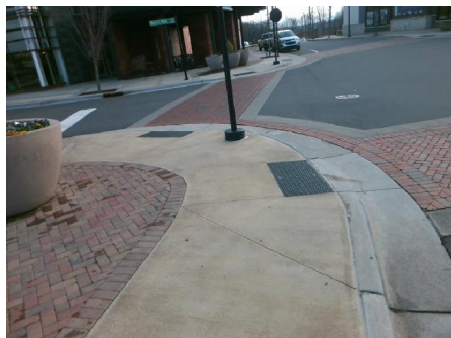
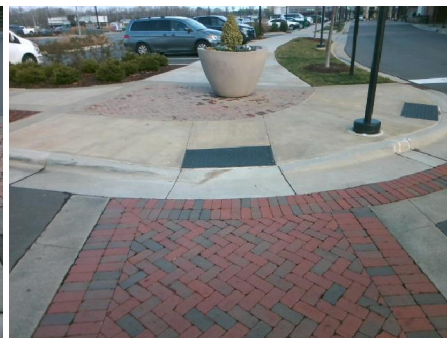
Compliance	Description	Data	Compliance	Description	Data
N/A	Ramp Length (in)	72.0	No	Ramp Slope (%)	8.8
Yes	Ramp Width (in)	48.0	No	Ramp XSlope (%)	5.3
N/A	Flare Type LT	N/A	N/A	Flare Type RT	N/A
N/A	Flare Slope LT (%)	N/A	N/A	Flare Slope RT (%)	N/A
N/A	Flare Traversable LT?	N/A	N/A	Flare Traversable RT?	N/A
N/A	Landing Length (in)	N/A	N/A	DWS Provided?	N/A
N/A	Landing Width (in)	N/A	N/A	DWS Contrast?	N/A
N/A	Landing Slope (%)	N/A	N/A	DWS Length (in)	N/A
N/A	Landing X Slope (%)	N/A	N/A	DWS Full Width?	N/A
N/A	Landing Curb? (Y/N)	N/A	N/A	DWS Offset (in)	N/A
N/A	Shared Landing?	N/A			
N/A	Gutter Ponding?	N/A	N/A	Gutter Slope (%)	N/A
N/A	Gutter Lip Ht (in)	N/A	N/A	Gutter X Slope (%)	N/A
N/A	Painted X Walk1?	Yes	N/A	Painted X Walk2?	N/A
	X Walk 1 Direction	To S		X Walk 2 Direction	N/A
N/A	X Walk 1 Width (in)	104.5	N/A	X Walk 2 Width (in)	N/A
	X Walk 1 Slope (%)	0.3		X Walk 2 Slope (%)	N/A
	X Walk 1 X Slope (%)	0.3		X Walk 2 X Slope (%)	N/A

N/A	Ramp inside XWalk1?	Yes	N/A	Ramp inside XWalk2?	N/A
	Road Slope (%)	N/A	N/A	Clear Space?	N/A
	Road X Slope (%)	N/A	N/A	Clear Space to XWalk (in)	N/A
N/A	Any Obstructions?	N/A	N/A	Storm Grate/Utility Hazard?	N/A
	Obstruction Type			Storm Grate/Utility Type	
		N/A			N/A
		Yes		Surface Condition? (G/P)	Good

Possible Solutions:

Remove & Replace Entire Ramp.

R304.2.2, R304.5.3
