# Access Compliance Report

## Public Rights-of-Way

### (Curb Ramps)

Intersection ID: 10040955	Main Street: WALNUT_FOREST_DR	Cross Street: N/A	Location: SE
ADA ID: 50E15C8EEE78	Ramp Type: Perp	Initial Pass/Fail: Fail	Overall Compliance: No
Codes/Mitigation Info/Possible Solution		Field Measurements/Component Compliance	
Severity Score: 8.75

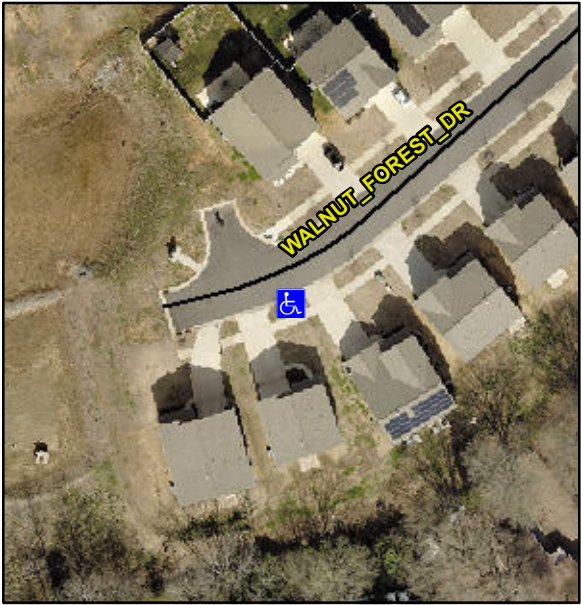
Possible Solutions:	Compliance	Description	Data	Compliance	Description	Data
	Remove & Replace Entire Ramp.	N/A	Ramp Length (in)	96.0	Yes	Ramp Slope (%)	6.7
		No	Ramp Width (in)	47.0	Yes	Ramp XSlope (%)	0.7
		N/A	Flare Type LT	N/A	N/A	Flare Type RT	N/A
		N/A	Flare Slope LT (%)	N/A	N/A	Flare Slope RT (%)	N/A
		N/A	Flare Traversable LT?	N/A	N/A	Flare Traversable RT?	N/A
		N/A	Landing Length (in)	N/A	N/A	DWS Provided?	N/A
		N/A	Landing Width (in)	N/A	N/A	DWS Contrast?	N/A
		N/A	Landing Slope (%)	N/A	N/A	DWS Length (in)	N/A
		N/A	Landing X Slope (%)	N/A	N/A	DWS Full Width?	N/A
<p>Surveyor Notes:</p> <p>N/A</p> <p>PROW/ADA:</p> <p>Not Found, R304.5.1</p>		N/A	Landing Curb? (Y/N)	N/A	N/A	DWS Offset (in)	N/A
		N/A	Shared Landing?	N/A			
		N/A	Gutter Ponding?	N/A	N/A	Gutter Slope (%)	N/A
		N/A	Gutter Lip Ht (in)	1.0	N/A	Gutter X Slope (%)	N/A
		N/A	Painted X Walk1?	No	N/A	Painted X Walk2?	N/A
			X Walk 1 Direction	To N		X Walk 2 Direction	N/A

N/A	X Walk 1 Width (in)	N/A	N/A	X Walk 2 Width (in)	N/A
			X Walk 1 Slope (%)	1.7		X Walk 2 Slope (%)	N/A
			X Walk 1 X Slope (%)	4.9		X Walk 2 X Slope (%)	N/A
		N/A	Ramp inside XWalk1?	N/A	N/A	Ramp inside XWalk2?	N/A
<p>Total Cost:</p> <p>\$ 1850.00</p>			Road Slope (%)	4.9	N/A	Clear Space?	N/A
			Road X Slope (%)	1.7	N/A	Clear Space to XWalk (in)	N/A
		N/A	Any Obstructions?	N/A	N/A	Storm Grate/Utility Hazard?	N/A
			Obstruction Type			Storm Grate/Utility Type	
					N/A		N/A
					Yes	Surface Condition? (G/P)	Good
