# Access Compliance Report

## Public Rights-of-Way

### (Curb Ramps)

Intersection ID: 26025	Main Street: CARMEL_COMMONS_BV	Cross Street: CARMEL_RD	Location: NW
ADA ID: 510062DC8B4E	Ramp Type: PerpDiag	Initial Pass/Fail: Fail	Overall Compliance: No
		Severity Score: 25

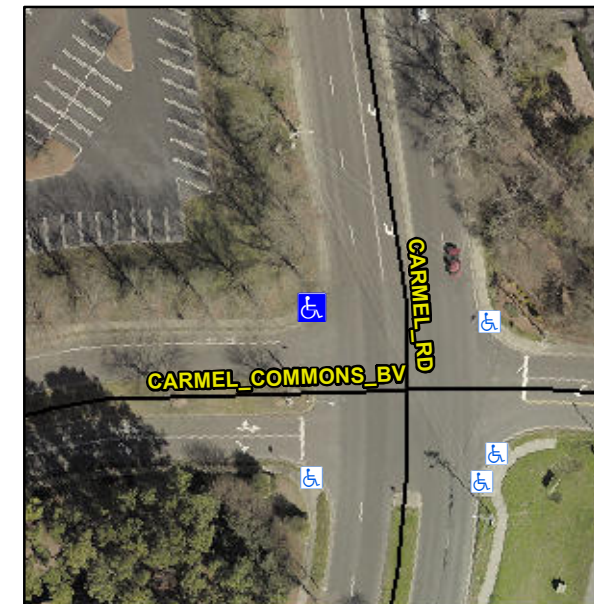
**Not Found, R304.2.2, R304.5.3**

Compliance	Description	Data	Compliance	Description	Data
N/A	Ramp Length (in)	57.0	No	Ramp Slope (%)	9.9
Yes	Ramp Width (in)	48.0	No	Ramp XSlope (%)	6.5
N/A	Flare Type LT	N/A	N/A	Flare Type RT	N/A
N/A	Flare Slope LT (%)	N/A	N/A	Flare Slope RT (%)	N/A
N/A	Flare Traversable LT?	N/A	N/A	Flare Traversable RT?	N/A
N/A	Landing Length (in)	N/A	N/A	DWS Provided?	N/A
N/A	Landing Width (in)	N/A	N/A	DWS Contrast?	N/A
N/A	Landing Slope (%)	N/A	N/A	DWS Length (in)	N/A
N/A	Landing X Slope (%)	N/A	N/A	DWS Full Width?	N/A
N/A	Landing Curb? (Y/N)	N/A	N/A	DWS Offset (in)	N/A
N/A	Shared Landing?	N/A			
N/A	Gutter Ponding?	N/A	N/A	Gutter Slope (%)	N/A
N/A	Gutter Lip Ht (in)	N/A	N/A	Gutter X Slope (%)	N/A
N/A	Painted X Walk1?	No	N/A	Painted X Walk2?	No
	X Walk 1 Direction	To S		X Walk 2 Direction	To E
N/A	X Walk 1 Width (in)	N/A	N/A	X Walk 2 Width (in)	N/A
	X Walk 1 Slope (%)	6.5		X Walk 2 Slope (%)	2.2
	X Walk 1 X Slope (%)	1.0		X Walk 2 X Slope (%)	8.1

N/A	Ramp inside XWalk1?	N/A	N/A	Ramp inside XWalk2?	N/A
	Road Slope (%)	4.7	N/A	Clear Space?	N/A
	Road X Slope (%)	6.7	N/A	Clear Space to XWalk (in)	N/A
N/A	Any Obstructions?	N/A	N/A	Storm Grate/Utility Hazard?	N/A
	Obstruction Type			Storm Grate/Utility Type	
		N/A			N/A
		Yes		Surface Condition? (G/P)	Good

**Remove & Replace Curb Ramp With Two New Directional Ramps or Equivalent.**
