Access Compliance Report

Public Rights-of-Way

(Curb Ramps)

Intersection ID: 12704	Main Street: E_5TH_ST	Cross Street: N_DAVIDSON_ST	Location: W
ADA ID: 512FFE72AEB6	Ramp Type: PerpDiag	Initial Pass/Fail: Fail	Overall Compliance: No
			Severity Score: 21.25

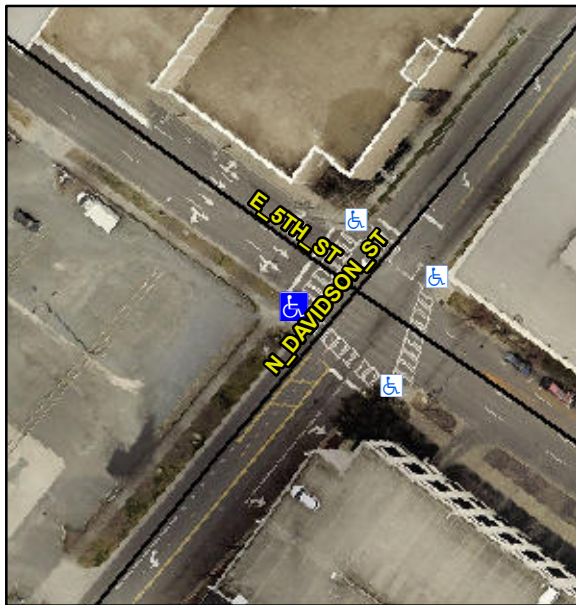
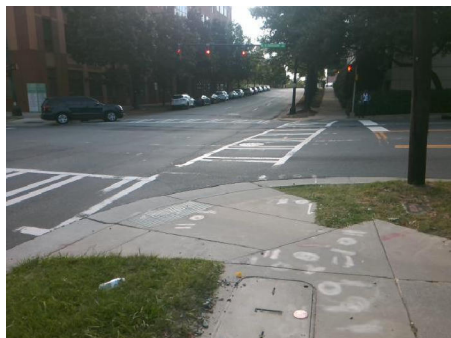
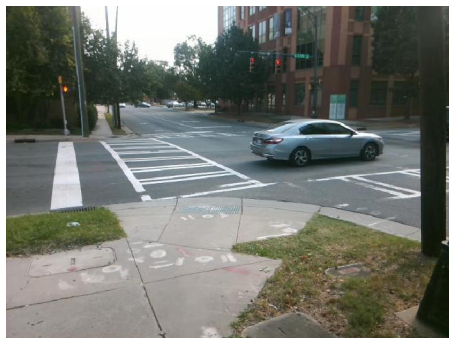
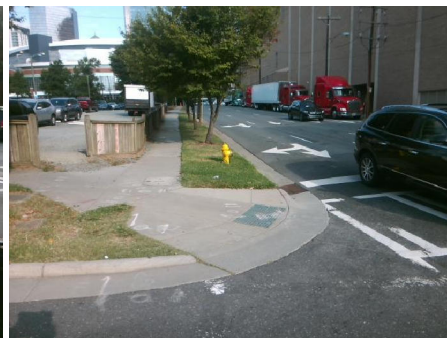
Not Found, R304.5.1, R304.2.2

Compliance	Description	Data	Compliance	Description	Data
N/A	Ramp Length (in)	96.0	No	Ramp Slope (%)	11.1
No	Ramp Width (in)	42.5	Yes	Ramp XSlope (%)	0.1
N/A	Flare Type LT	N/A	N/A	Flare Type RT	N/A
N/A	Flare Slope LT (%)	N/A	N/A	Flare Slope RT (%)	N/A
N/A	Flare Traversable LT?	N/A	N/A	Flare Traversable RT?	N/A
N/A	Landing Length (in)	N/A	N/A	DWS Provided?	N/A
N/A	Landing Width (in)	N/A	N/A	DWS Contrast?	N/A
N/A	Landing Slope (%)	N/A	N/A	DWS Length (in)	N/A
N/A	Landing X Slope (%)	N/A	N/A	DWS Full Width?	N/A
N/A	Landing Curb? (Y/N)	N/A	N/A	DWS Offset (in)	N/A
N/A	Shared Landing?	N/A			
N/A	Gutter Ponding?	N/A	N/A	Gutter Slope (%)	N/A
N/A	Gutter Lip Ht (in)	N/A	N/A	Gutter X Slope (%)	N/A
N/A	Painted X Walk1?	Yes	N/A	Painted X Walk2?	Yes
	X Walk 1 Direction	To SE		X Walk 2 Direction	To NE
N/A	X Walk 1 Width (in)	84.0	N/A	X Walk 2 Width (in)	104.0
	X Walk 1 Slope (%)	4.4		X Walk 2 Slope (%)	1.8
	X Walk 1 X Slope (%)	3.1		X Walk 2 X Slope (%)	2.4

N/A	Ramp inside XWalk1?	Yes	N/A	Ramp inside XWalk2?	Yes
	Road Slope (%)	3.3	N/A	Clear Space?	N/A
	Road X Slope (%)	2.2	N/A	Clear Space to XWalk (in)	N/A
N/A	Any Obstructions?	N/A	N/A	Storm Grate/Utility Hazard?	N/A
	Obstruction Type			Storm Grate/Utility Type	
		N/A			N/A
			Yes	Surface Condition? (G/P)	Good

Remove & Replace Curb Ramp With Two New Directional Ramps or Equivalent.
