# Access Compliance Report

## Public Rights-of-Way

### (Curb Ramps)

| Intersection ID: 14356 | Main Street: BAXTER_ST | Cross Street: S_TORRENCE_ST | Location: W |

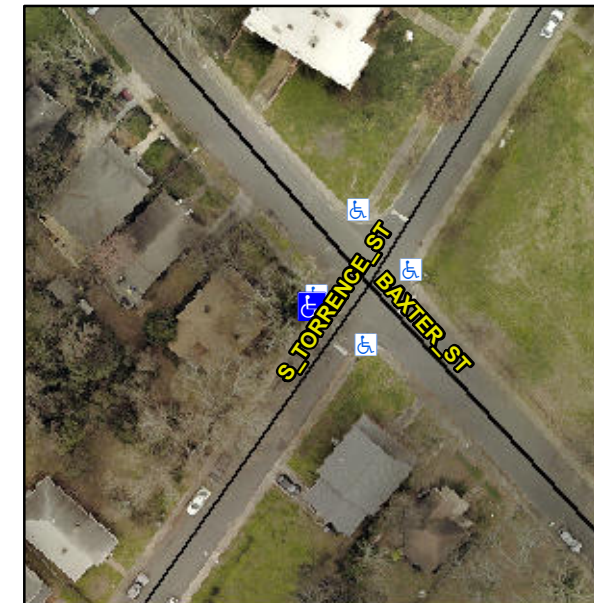
| ADA ID: 5130CE12257F | Ramp Type: Perp | Initial Pass/Fail: Fail | Overall Compliance: No |
| | | Severity Score: 25 | |

**R304.2.2**

| Compliance | Description | Data | Compliance | Description | Data |
|---|---|---|---|---|---|
| N/A | Ramp Length (in) | 48.0 | No | Ramp Slope (%) | 13.6 |

**Remove & Replace Entire Ramp.**

**\$ 1850.00**
