Access Compliance Report

Public Rights-of-Way

(Curb Ramps)

Intersection ID: 30099	Main Street: LARWILL_LN	Cross Street: STONEFORT_CT	Location: SE
ADA ID: 51325A9071E4	Ramp Type: PerpDiag	Initial Pass/Fail: Fail	Overall Compliance: No
		Severity Score: 22.5

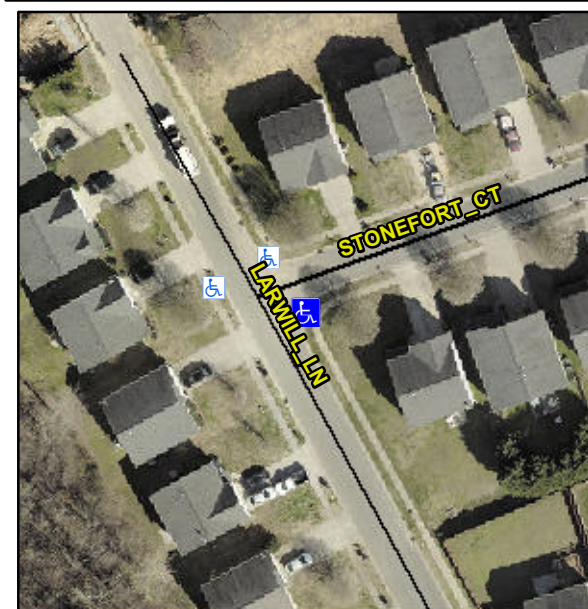
Compliance	Description	Data	Compliance	Description	Data
N/A	Ramp Length (in)	47.0	No	Ramp Slope (%)	11.1
No	Ramp Width (in)	37.0	No	Ramp XSlope (%)	3.4
N/A	Flare Type LT	N/A	N/A	Flare Type RT	N/A
N/A	Flare Slope LT (%)	N/A	N/A	Flare Slope RT (%)	N/A
N/A	Flare Traversable LT?	N/A	N/A	Flare Traversable RT?	N/A
N/A	Landing Length (in)	N/A	N/A	DWS Provided?	N/A
N/A	Landing Width (in)	N/A	N/A	DWS Contrast?	N/A
N/A	Landing Slope (%)	N/A	N/A	DWS Length (in)	N/A
N/A	Landing X Slope (%)	N/A	N/A	DWS Full Width?	N/A
N/A	Landing Curb? (Y/N)	N/A	N/A	DWS Offset (in)	N/A
N/A	Shared Landing?	N/A			
N/A	Gutter Ponding?	N/A	N/A	Gutter Slope (%)	N/A
N/A	Gutter Lip Ht (in)	0.5	N/A	Gutter X Slope (%)	N/A
N/A	Painted X Walk1?	No	N/A	Painted X Walk2?	No
	X Walk 1 Direction	To N		X Walk 2 Direction	To W
N/A	X Walk 1 Width (in)	N/A	N/A	X Walk 2 Width (in)	N/A
	X Walk 1 Slope (%)	0.3		X Walk 2 Slope (%)	1.8
	X Walk 1 X Slope (%)	2.7		X Walk 2 X Slope (%)	0.4

N/A	Ramp inside XWalk1?	N/A	N/A	Ramp inside XWalk2?	N/A
	Road Slope (%)	2.7	N/A	Clear Space?	N/A
	Road X Slope (%)	2.6	N/A	Clear Space to XWalk (in)	N/A
N/A	Any Obstructions?	N/A	N/A	Storm Grate/Utility Hazard?	N/A
	Obstruction Type			Storm Grate/Utility Type	
		N/A			N/A
			Yes	Surface Condition? (G/P)	Good

Possible Solutions:

Remove & Replace Curb Ramp With Two New Directional Ramps or Equivalent.
