Access Compliance Report

Public Rights-of-Way

(Curb Ramps)

Intersection ID: N/A		Main Street: SOUTH_BV		Cross Street: N/A		Location: SW							
ADA ID: 514B9031DE1C		Ramp Type: Directional1		Initial Pass/Fail: Fail		Overall Compliance: No		Severity Score: 1.25					
Codes/Mitigation Info/Possible Solution				Field Measurements/Component Compliance

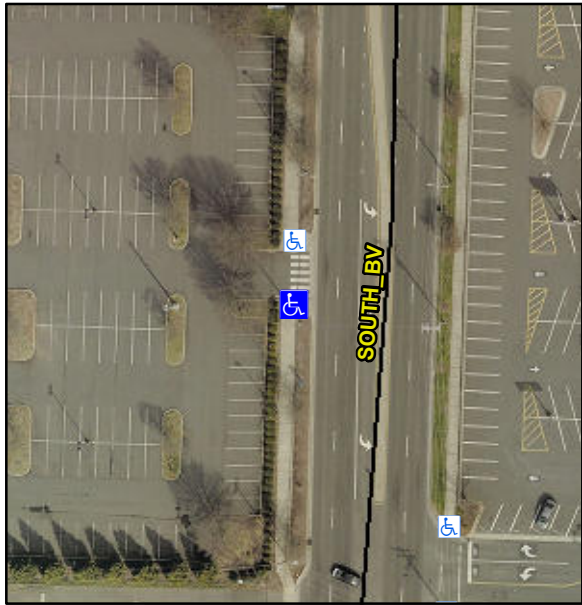
Possible Solutions:		Compliance		Description		Data			
				Remove & Replace Entire Ramp.		N/A	Ramp Length (in)	120.0		N/A	Grade Break?	N/A	
						Yes	Ramp Width (in)	98.0		N/A	Grade Break Slope (%)	0.0	
						Yes	Ramp Slope (%)	1.8		N/A	Grade Break XSlope (%)	0.0	
						No	Ramp XSlope (%)	2.3					
						N/A	Flare Type LT	N/A		N/A	Flare Type RT	N/A	
						N/A	Flare Slope LT (%)	N/A		N/A	Flare Slope RT (%)	0.0	
						N/A	Flare Traversable LT?	N/A		N/A	Flare Traversable RT?	N/A	
						N/A	Landing Length (in)	0.0		N/A	DWS Provided?	N/A	
						N/A	Landing Width (in)	0.0		N/A	DWS Contrast?	N/A	
Surveyor Notes: N/A PROW/ADA: R304.5.3				N/A	Landing Slope (%)	0.0		N/A	DWS Length (in)	N/A

N/A	Landing X Slope (%)	0.0		N/A	DWS Full Width?	N/A			
				N/A	Landing Curb? (Y/N)	N/A		N/A	DWS Offset LT (in)	N/A			
				N/A	Shared Landing?	N/A		N/A	DWS Offset RT (in)	N/A			
				N/A	Gutter Ponding?	0.0		N/A	Gutter Slope (%)	N/A			
				N/A	Gutter Lip Ht (in)	0.0		N/A	Gutter X Slope (%)	N/A			
				N/A	Painted X Walk1?	Yes			Road Slope (%)	0.3			
					X Walk 1 Direction	To N			Road X Slope (%)	0.9			
					X Walk 1 Width (in)	120.5			Clear Space?	N/A			
					X Walk 1 Slope (%)	0.3		N/A	Clear Space to XWalk (in)	N/A			
					X Walk 1 X Slope (%)	0.9		N/A	Storm Grate/Utility Hazard?	N/A			
				N/A	Ramp inside XWalk1?	Yes			Storm Grate/Utility Type				
				N/A	Any Obstructions?	N/A				N/A			
					Obstruction Type			Yes	Surface Condition? (G/P)	Good			
								N/A	Curb Slope (%)	5.0
