Access Compliance Report

Public Rights-of-Way

(Curb Ramps)

Intersection ID: 47842	Main Street: MANITOBA_LN	Cross Street: CACTUS_VALLEY_RD	Location: NE
ADA ID: 514EAF19E88A	Ramp Type: PerpDiag	Initial Pass/Fail: Fail	Overall Compliance: No
Severity Score: 8.75			
Codes/Mitigation Info/Possible Solution		Field Measurements/Component Compliance

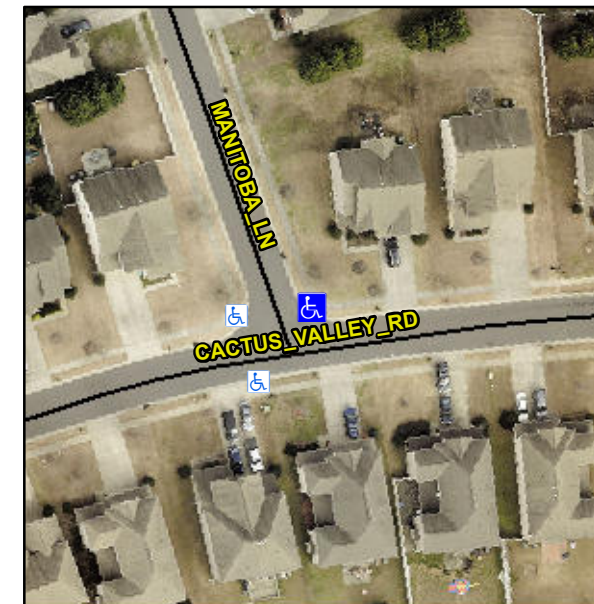
Compliance	Description	Data	Compliance	Description	Data
N/A	Ramp Length (in)	47.0	Yes	Ramp Slope (%)	5.2
No	Ramp Width (in)	47.0	Yes	Ramp XSlope (%)	1.0
N/A	Flare Type LT	N/A	N/A	Flare Type RT	N/A
N/A	Flare Slope LT (%)	N/A	N/A	Flare Slope RT (%)	N/A
N/A	Flare Traversable LT?	N/A	N/A	Flare Traversable RT?	N/A
N/A	Landing Length (in)	N/A	N/A	DWS Provided?	N/A
N/A	Landing Width (in)	N/A	N/A	DWS Contrast?	N/A
N/A	Landing Slope (%)	N/A	N/A	DWS Length (in)	N/A
N/A	Landing X Slope (%)	N/A	N/A	DWS Full Width?	N/A
N/A	Landing Curb? (Y/N)	N/A	N/A	DWS Offset (in)	N/A
N/A	Shared Landing?	N/A			
N/A	Gutter Ponding?	N/A	N/A	Gutter Slope (%)	N/A
N/A	Gutter Lip Ht (in)	N/A	N/A	Gutter X Slope (%)	N/A
N/A	Painted X Walk1?	No	N/A	Painted X Walk2?	No
	X Walk 1 Direction	To W		X Walk 2 Direction	To S
N/A	X Walk 1 Width (in)	N/A	N/A	X Walk 2 Width (in)	N/A
	X Walk 1 Slope (%)	0.7		X Walk 2 Slope (%)	2.4
	X Walk 1 X Slope (%)	0.5		X Walk 2 X Slope (%)	0.2

N/A	Ramp inside XWalk1?	N/A	N/A	Ramp inside XWalk2?	N/A
	Road Slope (%)	1.2	N/A	Clear Space?	N/A
	Road X Slope (%)	0.6	N/A	Clear Space to XWalk (in)	N/A
N/A	Any Obstructions?	N/A	N/A	Storm Grate/Utility Hazard?	N/A
	Obstruction Type			Storm Grate/Utility Type	
		N/A			N/A
		Yes		Surface Condition? (G/P)	Good

Possible Solutions:

Remove & Replace Curb Ramp With Two New Directional Ramps or Equivalent.

R304.5.1

Total Cost: \$ 3200.00
