# Access Compliance Report

## Public Rights-of-Way

### (Curb Ramps)

Intersection ID: 10942	Main Street: S I-77 EXIT 10B RA	Cross Street: S I-77 EXIT 10C RA	Location: W
ADA ID: 5155AD416255	Ramp Type: Directional1	Initial Pass/Fail: Fail	Overall Compliance: No
		Severity Score: 12.5

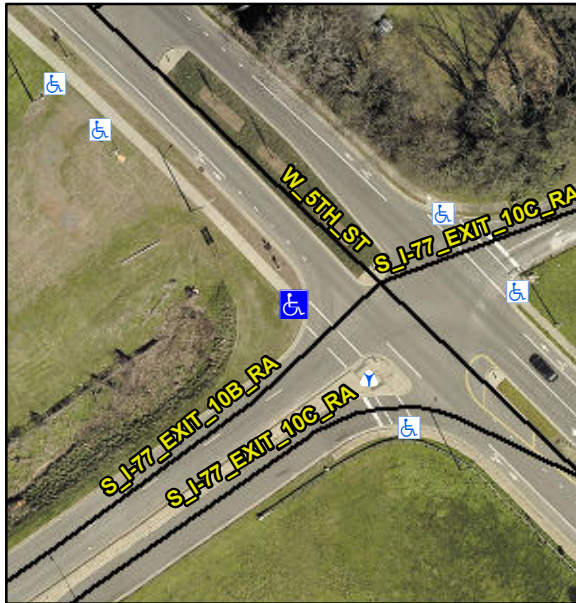
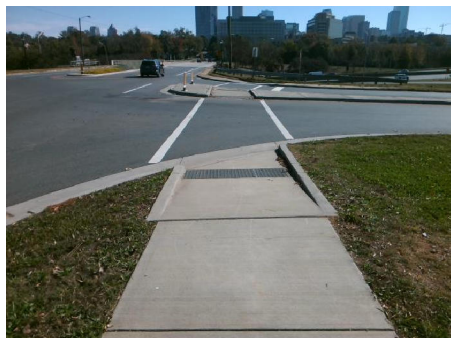
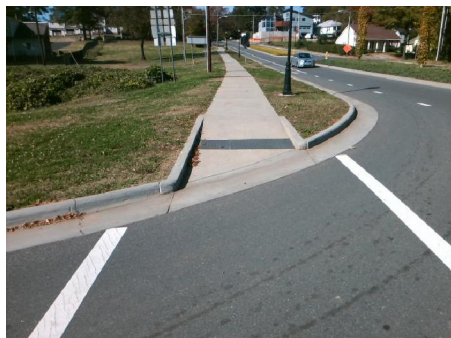
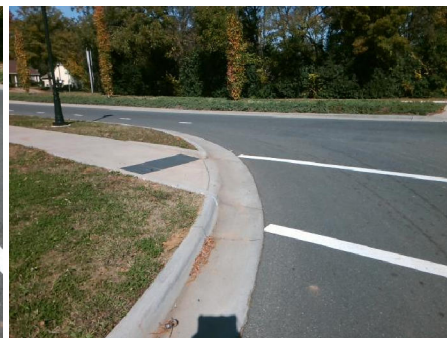
**R304.2.2**

Compliance	Description	Data	Compliance	Description	Data
N/A	Ramp Length (in)	96.5	N/A	Grade Break?	N/A
Yes	Ramp Width (in)	72.0	N/A	Grade Break Slope (%)	0.0
No	Ramp Slope (%)	9.4	N/A	Grade Break XSlope (%)	0.0
Yes	Ramp XSlope (%)	0.2			
N/A	Flare Type LT	N/A	N/A	Flare Type RT	N/A
N/A	Flare Slope LT (%)	N/A	N/A	Flare Slope RT (%)	0.0
N/A	Flare Traversable LT?	N/A	N/A	Flare Traversable RT?	N/A
N/A	Landing Length (in)	0.0	N/A	DWS Provided?	N/A
N/A	Landing Width (in)	0.0	N/A	DWS Contrast?	N/A
N/A	Landing Slope (%)	0.0	N/A	DWS Length (in)	N/A
N/A	Landing X Slope (%)	0.0	N/A	DWS Full Width?	N/A
N/A	Landing Curb? (Y/N)	N/A	N/A	DWS Offset LT (in)	N/A
N/A	Shared Landing?	N/A	N/A	DWS Offset RT (in)	N/A
N/A	Gutter Ponding?	0.0	N/A	Gutter Slope (%)	N/A
N/A	Gutter Lip Ht (in)	0.0	N/A	Gutter X Slope (%)	N/A
N/A	Painted X Walk1?	Yes		Road Slope (%)	2.1
	X Walk 1 Direction	To SE		Road X Slope (%)	2.3
	X Walk 1 Width (in)	112.0		Clear Space?	N/A

X Walk 1 Slope (%)	2.1	N/A	Clear Space to XWalk (in)	N/A
	X Walk 1 X Slope (%)	2.3	N/A	Storm Grate/Utility Hazard?	N/A
N/A	Ramp inside XWalk1?	Yes		Storm Grate/Utility Type	
N/A	Any Obstructions?	N/A			N/A
	Obstruction Type		Yes	Surface Condition? (G/P)	Good
			N/A	Curb Slope (%)	6.9

**Remove & Replace Entire Ramp.**
