Access Compliance Report

Public Rights-of-Way (Curb Ramps)

Intersection ID: 9884	Main Street: BEDFORD_GREEN_LN	Cross Street: ROCESTER_DR	Location: SW
ADA ID: 5158592B2FBA	Ramp Type: Directional1	Initial Pass/Fail: Fail	Overall Compliance: No
		Severity Score: 12.5

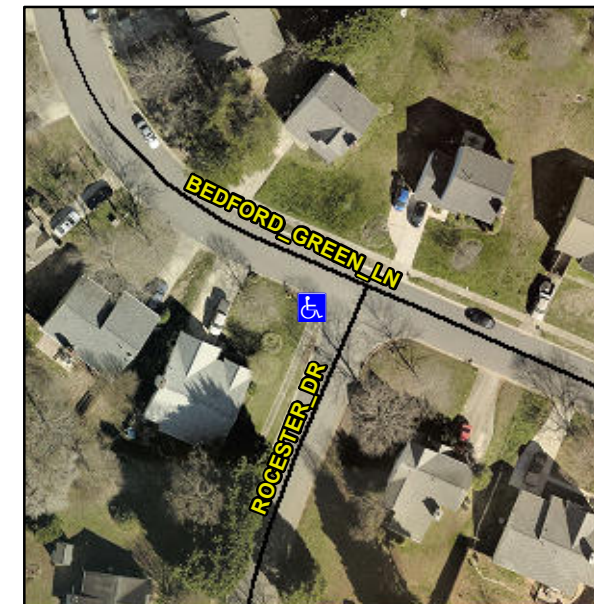
Compliance	Description	Data	Compliance	Description	Data
N/A	Ramp Length (in)	24.0	N/A	Grade Break?	N/A
Yes	Ramp Width (in)	48.0	N/A	Grade Break Slope (%)	0.0
No	Ramp Slope (%)	11.2	N/A	Grade Break XSlope (%)	0.0
Yes	Ramp XSlope (%)	2.0			
N/A	Flare Type LT	N/A	N/A	Flare Type RT	N/A
N/A	Flare Slope LT (%)	N/A	N/A	Flare Slope RT (%)	0.0
N/A	Flare Traversable LT?	N/A	N/A	Flare Traversable RT?	N/A
N/A	Landing Length (in)	0.0	N/A	DWS Provided?	N/A
N/A	Landing Width (in)	0.0	N/A	DWS Contrast?	N/A
N/A	Landing Slope (%)	0.0	N/A	DWS Length (in)	N/A
N/A	Landing X Slope (%)	0.0	N/A	DWS Full Width?	N/A
N/A	Landing Curb? (Y/N)	N/A	N/A	DWS Offset LT (in)	N/A
N/A	Shared Landing?	N/A	N/A	DWS Offset RT (in)	N/A
N/A	Gutter Ponding?	0.0	N/A	Gutter Slope (%)	N/A
N/A	Gutter Lip Ht (in)	0.0	N/A	Gutter X Slope (%)	N/A
N/A	Painted X Walk1?	No		Road Slope (%)	2.5
	X Walk 1 Direction	To NE		Road X Slope (%)	2.9
	X Walk 1 Width (in)	N/A		Clear Space?	N/A

X Walk 1 Slope (%)	2.5	N/A	Clear Space to XWalk (in)	N/A
	X Walk 1 X Slope (%)	2.9	N/A	Storm Grate/Utility Hazard?	N/A
N/A	Ramp inside XWalk1?	N/A		Storm Grate/Utility Type	
N/A	Any Obstructions?	N/A			N/A
	Obstruction Type		Yes	Surface Condition? (G/P)	Good
			N/A	Curb Slope (%)	21.4

Possible Solutions:

Remove & Replace Entire Ramp.
